TITEL: Kontroll av bränsletankarnas urluftsningrör

GÄLLER: Modell R22 S/N 0002 tom 1451 se även under compliance i FAA AD 98-21-09

PRIORITY LETTER AIRWORTHINESS DIRECTIVE **Bilaga till LVD 2912**

98-21-09 ROBINSON HELICOPTER COMPANY: Docket No. 98-SW-45-AD.

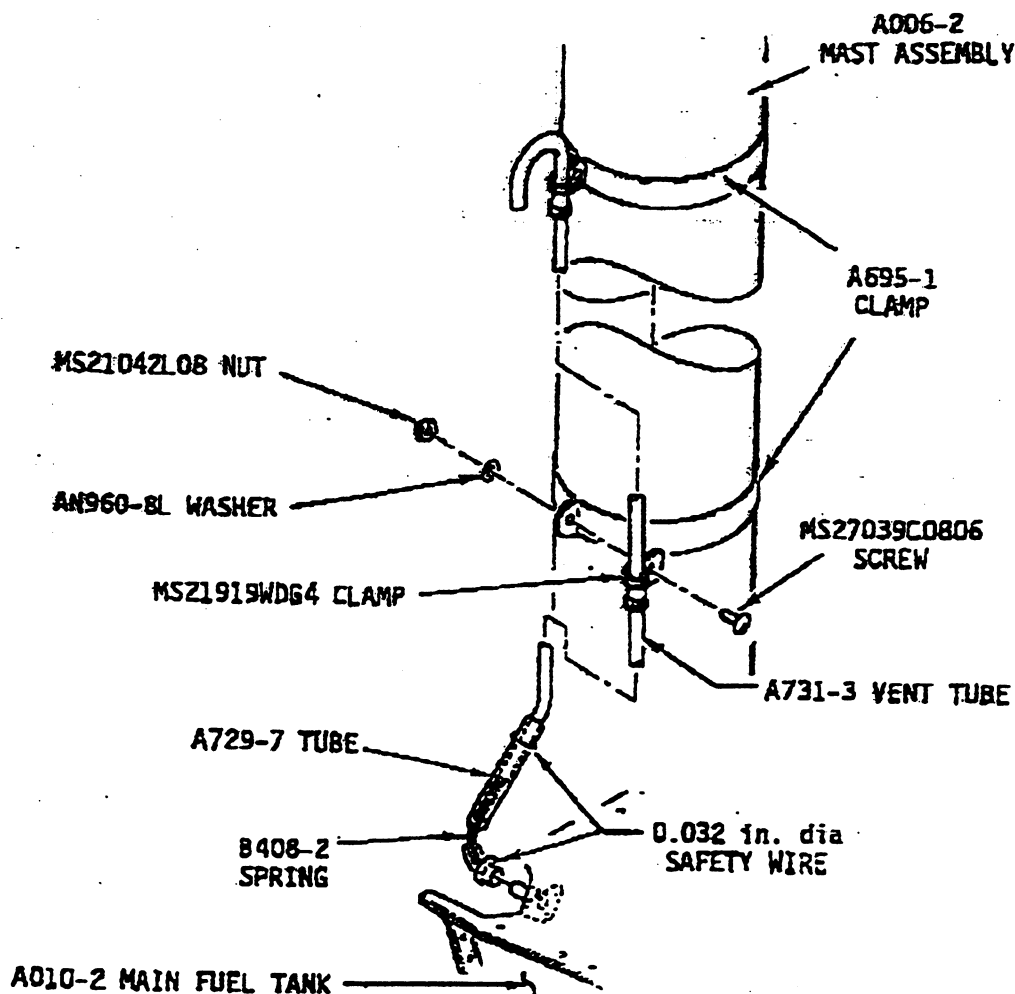
FIGURE 1
AD 98-21-09

HELICOPTER WITHOUT AUXILIARY FUEL TANK

(1) For helicopters without an auxiliary fuel tank installed, remove the existing vent tube, P/N A731-1, and install an airworthy vent tube, P/N A731-3, with flexible tube, P/N A729-7, using a MS27039C0806 screw and AN960-8L washer (alternate P/N NAS1149FN816P) at the lower clamp, P/N A695-1 (see Figure 1).

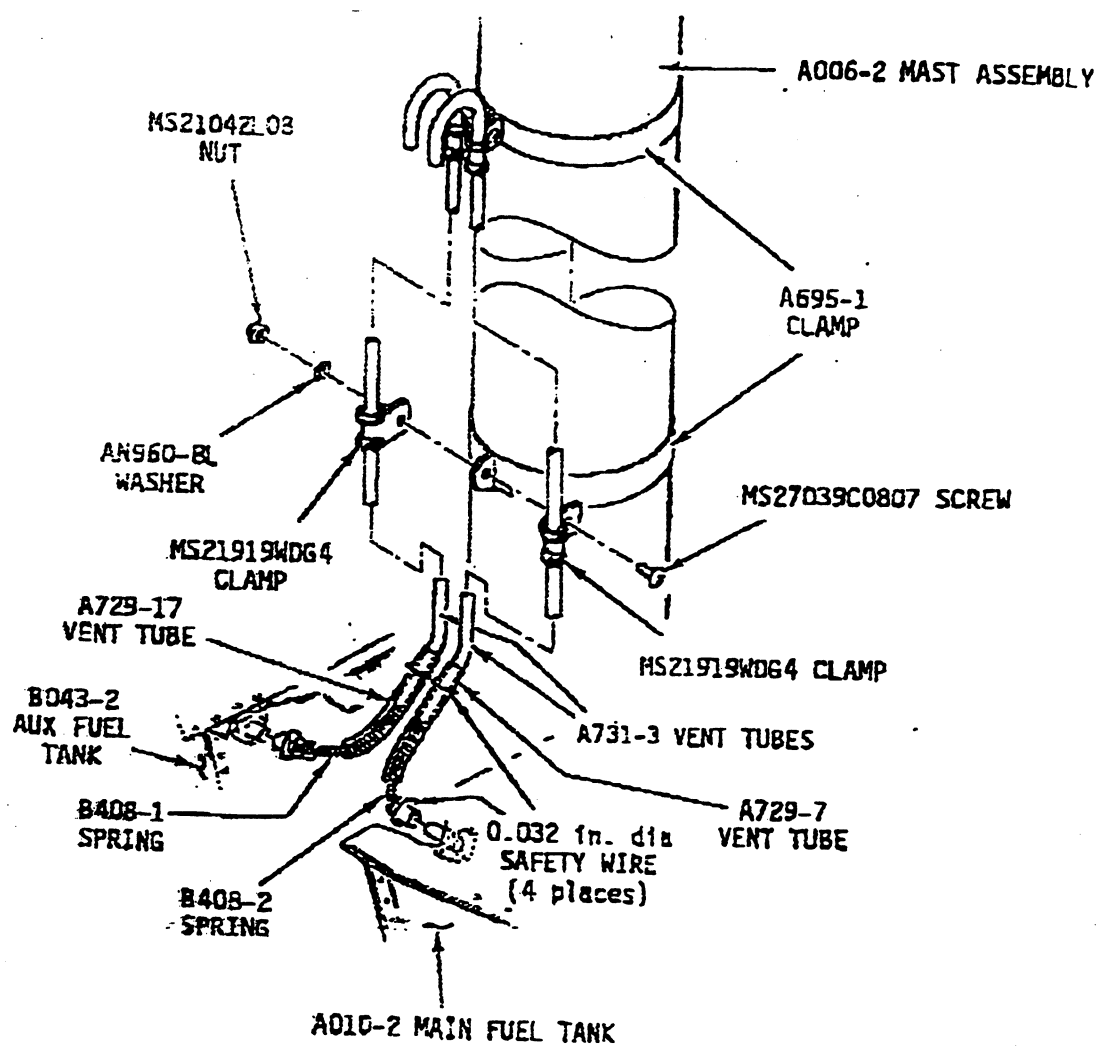
FIGURE 2
AD 98-21-09

HELICOPTER WITH AUXILIARY FUEL TANK

(2) For helicopters with an auxiliary fuel tank installed, remove the existing main fuel tank vent tube, P/N A731-1, and auxiliary fuel tank vent tube, P/N A731-2, and install airworthy vent tubes, P/N A731-3, with flexible tube, P/N A729-7, for main tank and flexible tube, P/N A729-17, for auxiliary tank using MS27039C0807 screw and AN960-8L washer (alternate P/N NAS1149FN816P) at lower clamp, P/N A695-1 (see Figure 2).
