TITEL: Installation av avstängningsklämma i extra bränsletankens dräneringssystem

GÄLLER: R44 S/N 0002 t o m 0529 undantaget 0440, 0485, 0512, 0515, 0519, 0526, 0527 och 0528

LFS 1999:124

99-13-11 ROBINSON HELICOPTER COMPANY: Amendment 39-11204. Docket No. 98-SW-71-AD.

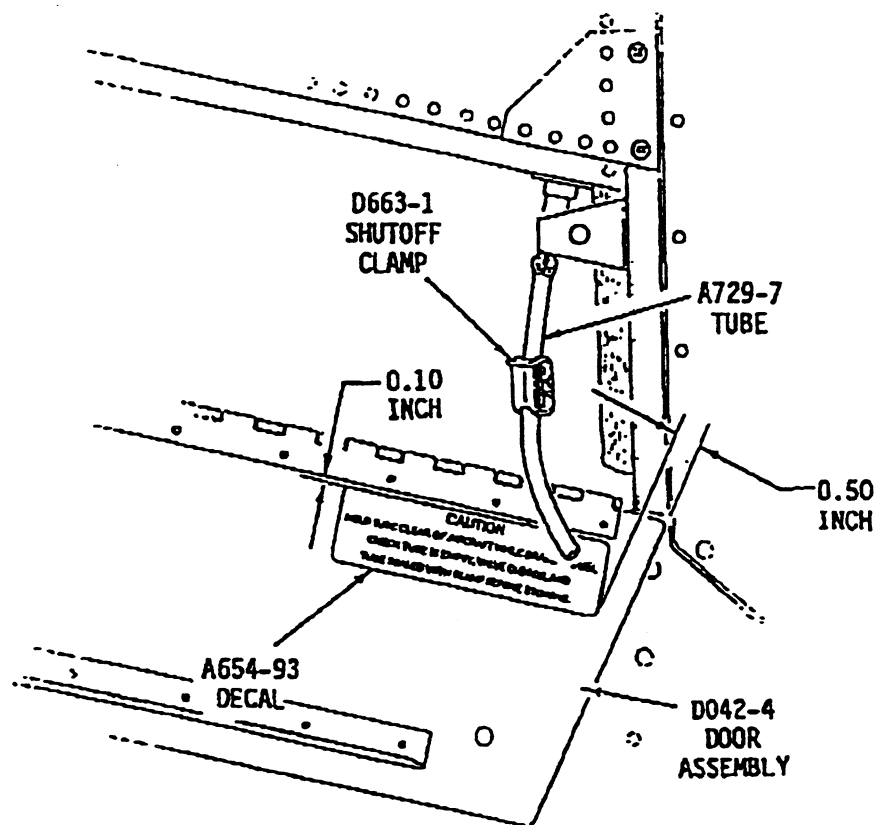
FIGURE 1
AD 99-13-11

To prevent fuel leaks from the auxiliary fuel tank sump drain, which could cause a fire and subsequent loss of control of the helicopter, accomplish the following:

- (a) Install a shutoff clamp, part number (P/N) D663-1, by sliding it onto the auxiliary fuel tank sump drain tube, P/N A729-7, as shown in Figure 1.
- (b) Install placard decal, P/N A654-93, as shown in Figure 1.
- (c) An alternative method of compliance or adjustment of the compliance time that provides an acceptable level of safety may be used if approved by the Manager, Los Angeles Aircraft Certification Office. Operators shall submit their requests through an FAA Principal Maintenance Inspector, who may concur or comment and then send it to the Manager, Los Angeles Aircraft Certification Office.
