TITEL: Kontroll av elkablage och bränslerör för skavskador

GÄLLER: R44 S/N 0002 t.o.m. 0462

REFERENS: FAA AD 2000-07-03

2000-07-03 ROBINSON HELICOPTER COMPANY: Amendment 39-11657. Docket No. 99-SW-08-AD.

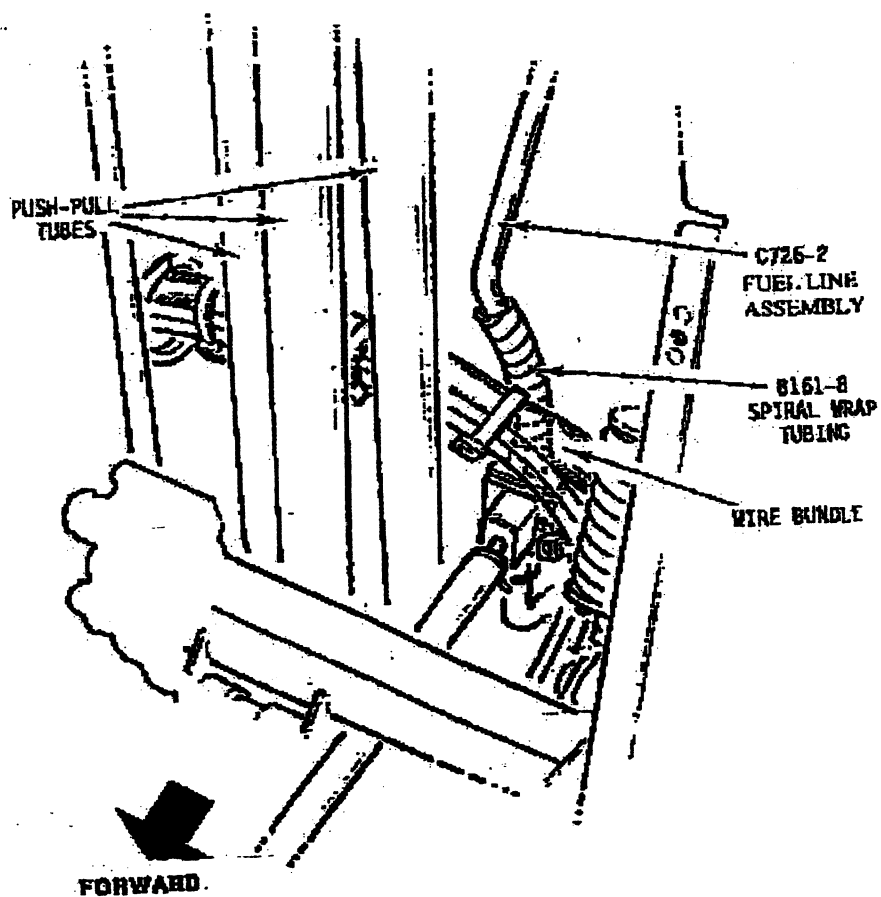
FIGURE 1

To prevent contact between the wire harness and the fuel line assembly, which could result in chafing of the wire harness and a potential fire hazard, accomplish the following:

- (a) Remove the cover, part number (P/N) C474-1, from between the rear seatbacks.
- (b) Inspect the wire harness, P/N C059, and the fuel line assembly, P/N C726-2, above the fuel shutoff valve for contact. If the wire harness contacts the fuel line assembly, inspect for chafing.
- (c) If chafing has occurred between the wire harness and the fuel line assembly, replace the fuel line with an airworthy fuel line assembly. Torque the fuel line nuts to 110-130 in-lbs. Verify that clearance exists between the fuel line assembly and the wire harness.
- (d) Install a 3-inch section of spiral wrap tubing, P/N B161-8, on the fuel line assembly as shown in Figure 1. Push the spiral wrap tubing down until it is against the fuel line fitting.
