TITEL: Sprickkontroll av omställningsarm för styrplatta

GÄLLER: Modell R22 med installerad omställningsarm P/N A203-5.

EMERGENCY AIRWORTHINESS DIRECTIVE

**DATE: October 4, 2000
2000-20-51**

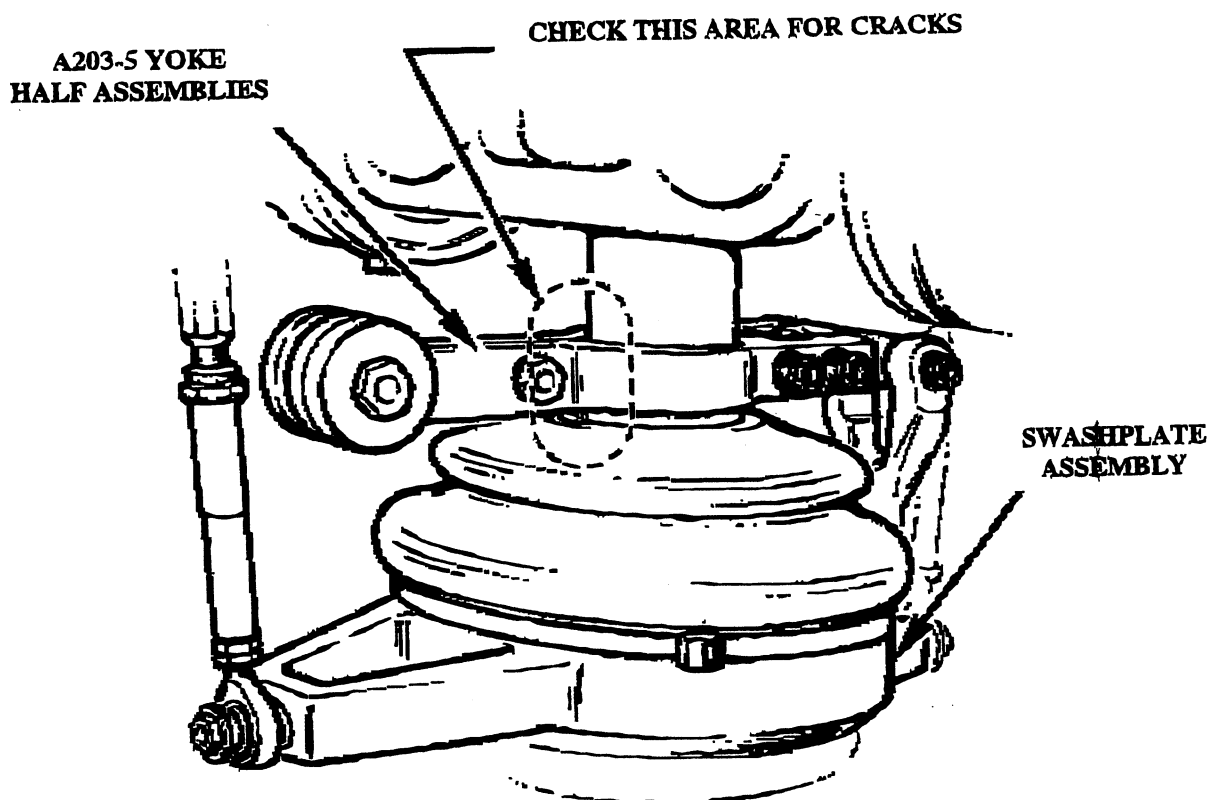
Figure A

This Emergency Airworthiness Directive (AD) is prompted by several reports of cracks in the yoke half assembly (yoke), part number (P/N) A203-5, during pre-flight inspections. The cracked yokes were still in service and functioned for an unknown duration. Several lots of the yokes were machined from 2024-T3 aluminum billet, which has poor stress corrosion properties in the transverse grain directions. Clamping the yokes in place causes a preload tension in areas that have exposed transverse grain. When these areas are exposed to a corrosive environment, such as salty air, stress corrosion causes crack formation and growth. This condition, if not corrected, could result in separation of the yokes from the main rotor drive shaft and subsequent loss of control of the helicopter.

- (a) Before further flight and thereafter before the first flight of each day, check each yoke for a crack. See Figure A.
- (b) If a yoke is cracked, before further flight, replace the yokes with airworthy yokes, P/N A203-7. Both yokes must be replaced with yokes, P/N A203-7.
- (c) Before further flight after January 1, 2001,
 - (1) Determine the Lot identifier of each yoke.
 - (2) If the Lot identifier is from 24 through 43, if it is a letter code, or if it is illegible, replace yokes, P/N A203-5, with airworthy yokes, P/N A203-7. Yoke, P/N A203-7, cannot be installed with yoke, P/N A203-5.
