TITEL: Kontroll av huvudrotoraxel.

GÄLLER: Enstrom Helicopter Corporation modeller F-28, F-28A, F-28C, F-28F, 280, 280C, 280F och 280FX.

LFS 2002:55

2002-08-03 Enstrom Helicopter Corporation: Amendment 39-12710. Docket No. 2001-SW-67-AD. Supersedes AD 2001-22-01, Amendment 39-12479, Docket No. 2001-SW-28-AD.

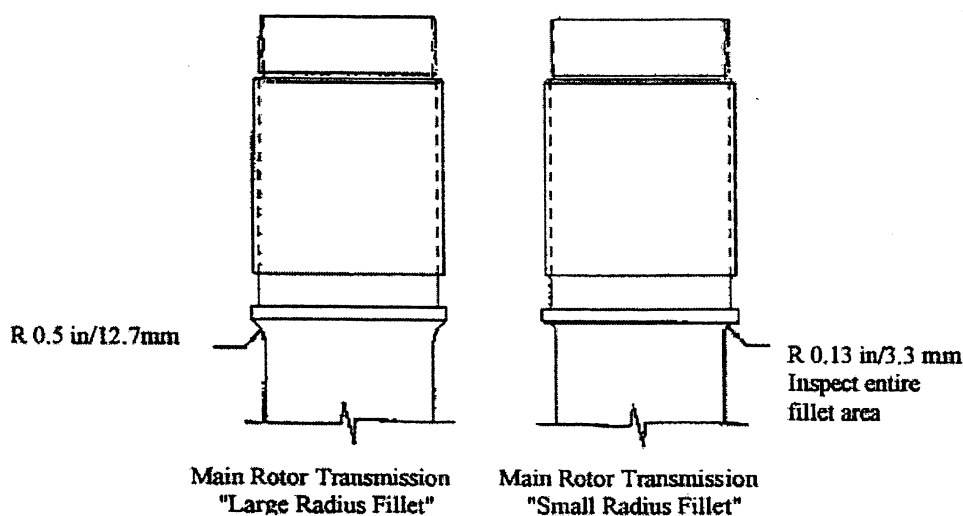
Figure 1. Main Rotor Shaft Inspection

(a) Before further flight, determine the part number (P/N) of the main rotor transmission (transmission) and the radius of the upper fillet of the shaft (as shown in the following Figure 1):

(2) If the installed transmission is P/N 28-13101-1 or -1-R, or P/N 28-13101-3 or -3-R, and has a small radius shaft, before further flight and thereafter at intervals not to exceed 25 hours TIS, visually inspect each transmission for a crack in the shaft upper fillet using a 10X or higher magnifying glass.

- (i) Dye-penetrant inspect the shaft upper fillet for a crack, a nick, or a scratch.
 - (ii) Polish out nicks or scratches less than 0.005-inch deep.
 - (iii) If the shaft is cracked or has a nick or scratch 0.005 inch or more deep, replace the transmission with an airworthy transmission having a large radius shaft fillet before further flight.
- (4) Within 300 hours TIS or at the next overhaul after the effective date of this AD, whichever occurs first, replace transmission, P/N 28-13101-1 or -1-R, or P/N 28-13101-3 or -3-R, with an airworthy transmission having a large radius shaft fillet.

(b) For EHC Model F-28C, F-28F, 280C, 280F, and 280FX helicopters, before further flight, replace any transmission having a small radius shaft fillet with an airworthy transmission having a large radius shaft fillet as specified in Table 1 of this AD.

(1) If the transmission has a shaft with a small radius fillet and the transmission P/N is not listed in Table 1, before further flight, replace the transmission with an airworthy transmission specified in the following Table 1 of this AD:

(ii) If the shaft is cracked, before further flight, replace the transmission with an airworthy transmission having a large radius shaft fillet.
