**TITEL:** Inspektion av bultar till stjärtrotorväxellåda

**GÄLLER:** MD Helicopters Inc. modellerna 369D, 369E, 369F och 369FF  
modifierade enligt STC SH5055NM eller SH4801NM

**LFS** 2002:96

**2002-13-05 MD Helicopters, Inc.: Amendment 39-12793. Docket No. 2001-SW-40-AD.**

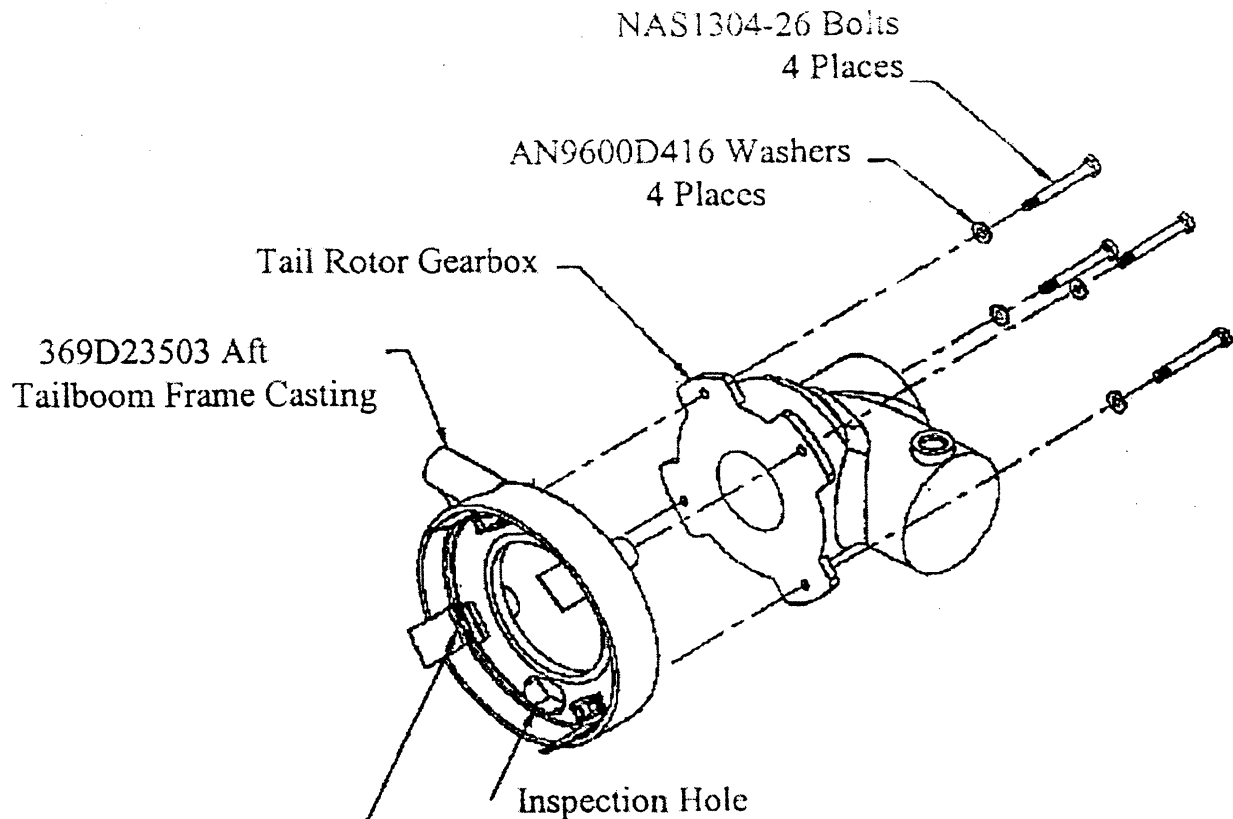
**Figure 1 - Inspection Location**

To prevent loss of the tail rotor gearbox due to attaching bolts of inadequate grip length and subsequent loss of helicopter control, accomplish the following:

(2) Remove the tailboom control rod and determine the number of bolt threads protruding from each nutplate on the internal surface of the aft tailboom frame casting, P/N 369D23503, as shown in Figure 1 of this AD. At least one thread must protrude. If more than four threads protrude, add an additional washer, P/N AN960D416, under the bolt head. Torque the bolt to 100-110 in-lbs, and reapply a slippage mark. See Figure 1:

Inspect this area of each bolt.  
Bolt must protude at least one  
thread past end of nutplate  
4 places.

(b) Between 2 and 10 hours TIS after accomplishing the requirements of paragraph (a) of this AD, inspect the torque on each bolt by applying 100 in-lbs. If any bolt movement occurs, retorque the bolt to 100-110 in-lbs and reapply a slippage mark. Reinspect the torque between 2 and 10 hours TIS thereafter until no bolt movement occurs.
