**TITEL:** Kontroll av bränslepump

**GÄLLER:** Franklin motorer modeller 6A-350-C1R, 6A-350-C1L, 4A-235-B4, 4A-235-B31

**DYREKTYWA ZDATNOŚCI - AIRWORTHINESS DIRECTIVE**  
**Nr SP -0071 -2002-B**

NUMBER: PZL-F/68/2002

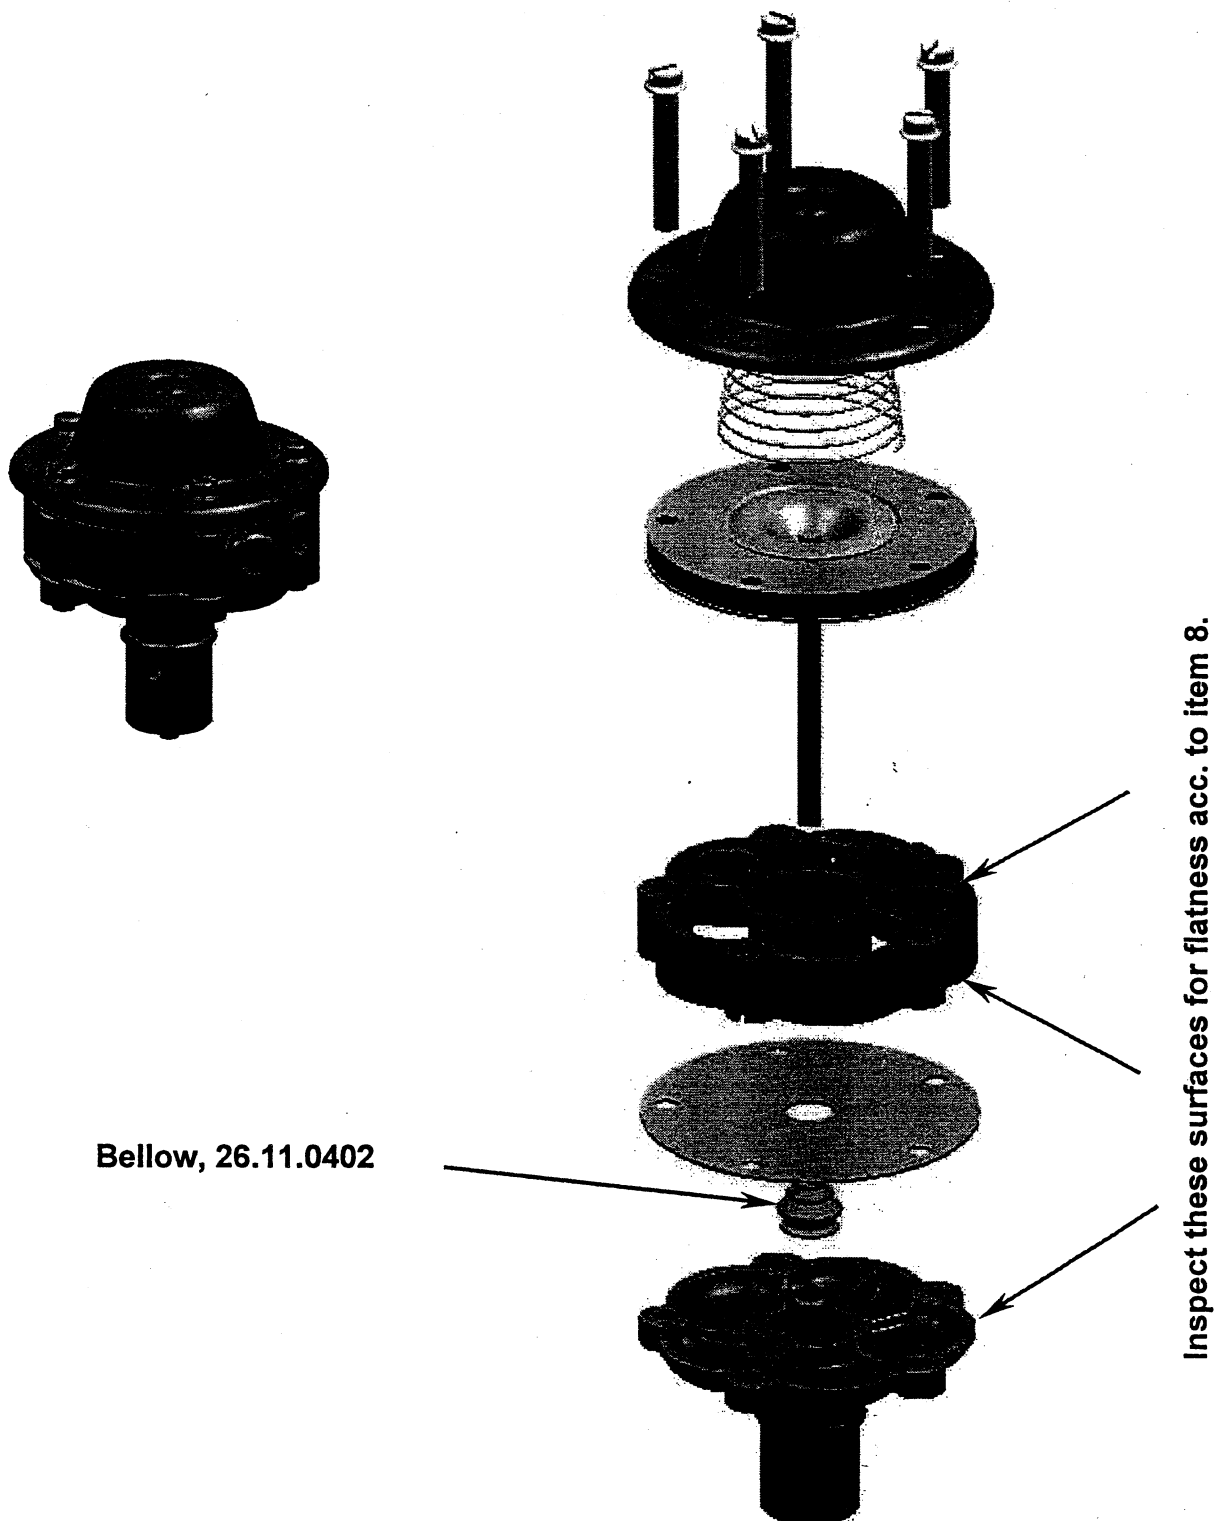
Fig. 1.

3. Disassemble the fuel pump /Fig. 1/.

8. Check pump sealing surfaces for their condition (flatness) – see *Fig. 1*. Inspect the surface by an ink test. Any breaks in contact areas are not allowed. Repair the elements by grinding or lapping as necessary.
9. Inspect the fuel valves. Only the valves of type I are permitted for continued operation. If any valve of type II is found, replace the pump. /*Fig. 4*/.

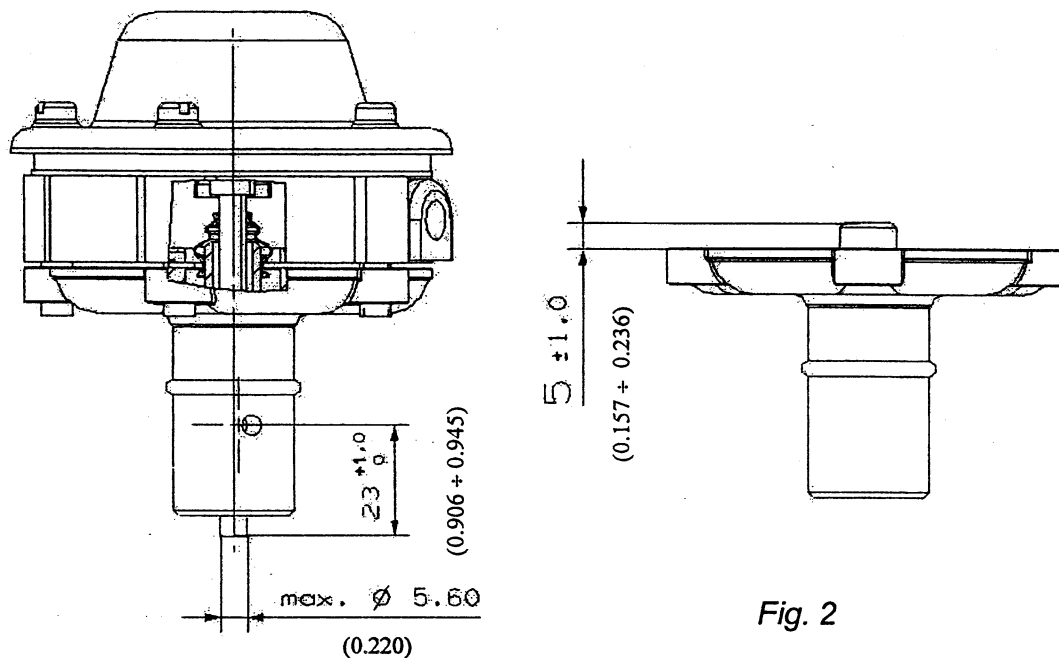
Fig. 2

1. Check the period of pump operation. Any pump being operated over 10 years shall be replaced for a new one.
2. Measure the distance between the lifter and the axis of the pump casing bolt hole (26.21.0157). This distance shall be  $23^{+1}$  mm (0,905-0,945 in) /Fig. 2/. If this dimension is higher, the lifter shall be ground to obtain the dimension from 23 mm (0,905 in) to 24 mm (0.945).

4. Check the height of the seating element of the rubber bellow /see Fig. 2/. This element shall be  $5 \pm 1$  (0.157 – 0.236 in). Correct it by milling or filing if necessary.

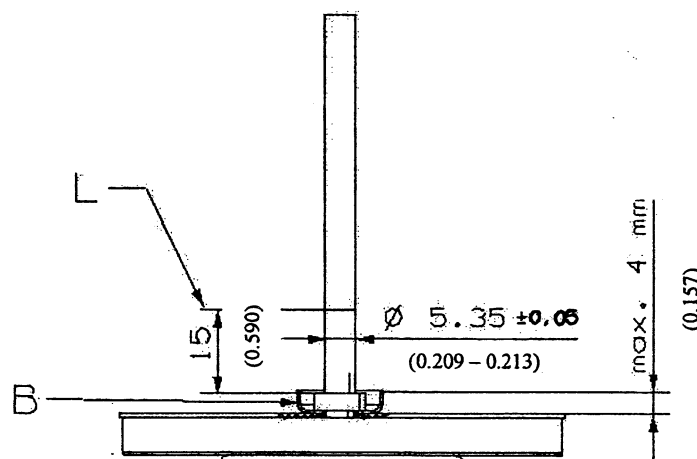
Fig. 3

5. Inspect the pump elements visually for cracks and delamination of rubber and cracks of casing.
6. Measure the lifter thickness. It shall be  $5.35 \pm 0.05$  mm (0.209 – 0.213) of dia. in the area of contacting with the bellow (26.11.0402) at "L" distance /see Fig. 3./ and max. of 5.60 mm (0.22) of dia. in remaining areas /Fig. 2/. Grind the lifter or replace with a new one if necessary.
7. Measure the height of the cup / see Fig. 3., designation "B"/. It shall be a max. of 4 mm (0.157) in height. Repair it by grinding or filing if necessary, see Fig. 3.

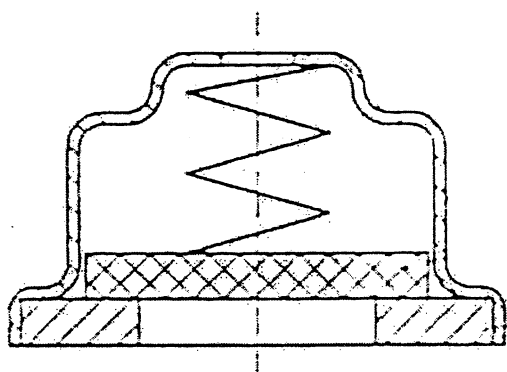
*Fig. 4*

Valve of type „I”

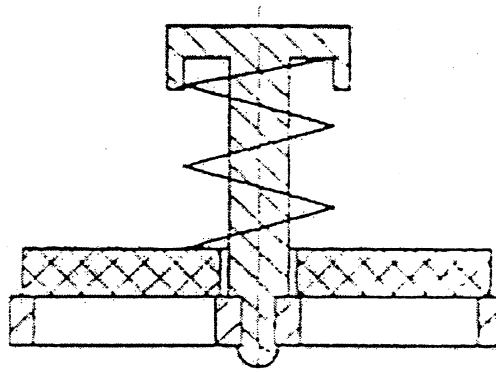
Valve of type „II”
