## LUFTVÄRDIGHETSDIREKTIV

**TITEL:** Revision av AFM, kontroll och modifiering av höjdrodertrim

**LFS:** 1987:9

Beechcraft SB No 2028 Rev III

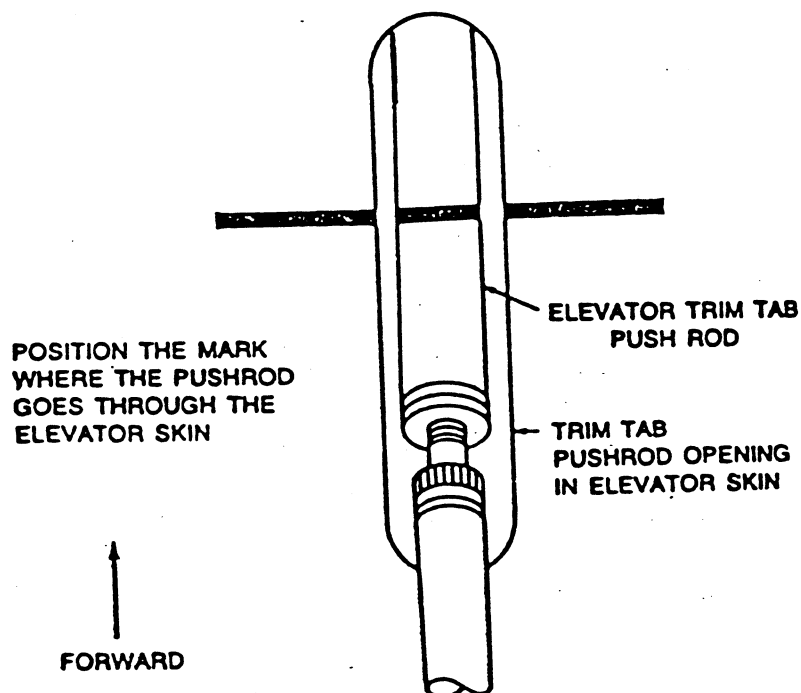
Pushrod Marking (Temporary)  
Figure 1

1. Elevator Trim Tab
  - a. VERIFY "O" (NEUTRAL) POSITION
2. On Model 65-A90, B90, C90, C90A and E90 airplanes, the elevator trim tab "O" (neutral) position is determined by observing that the alignment marks on the elevator trim tab pushrods align with the alignment marks on the elevator (See Figure 1 or 2 below), when the elevator is resting against the downstops.
