Sektion 2. Utlandstillverkad flygmateriel

TITEL: Kontroll/utbyte av stolinfästningsdetaljer

GÄLLER: Alla Cessna, som uppräknas i bifogad AD-note 87-20-03 R2

87-20-03 R2 CESSNA: Amendment 39-5729, as revised by Amendment 39-5863, is further revised by Amendment 39-6669. Docket No. 86-CE-71-AD.

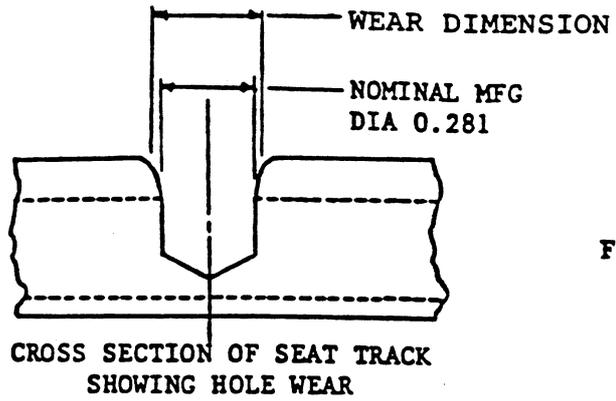
FIGURE 1

(1) Measure each hole in the seat track(s) for excessive wear. When checking these holes for wear, an allowance of 0.020 inches below the edge of the normal surface is permitted for the required measurement.

(i) If the wear dimension across any hole exceeds 0.36 inches but does not exceed 0.42 inches (see Figure 1), continue to measure each hole every 100 hours TIS for excessive wear.

(ii) If the wear dimension across any hole exceeds 0.42 inches, prior to further flight, replace the seat track.

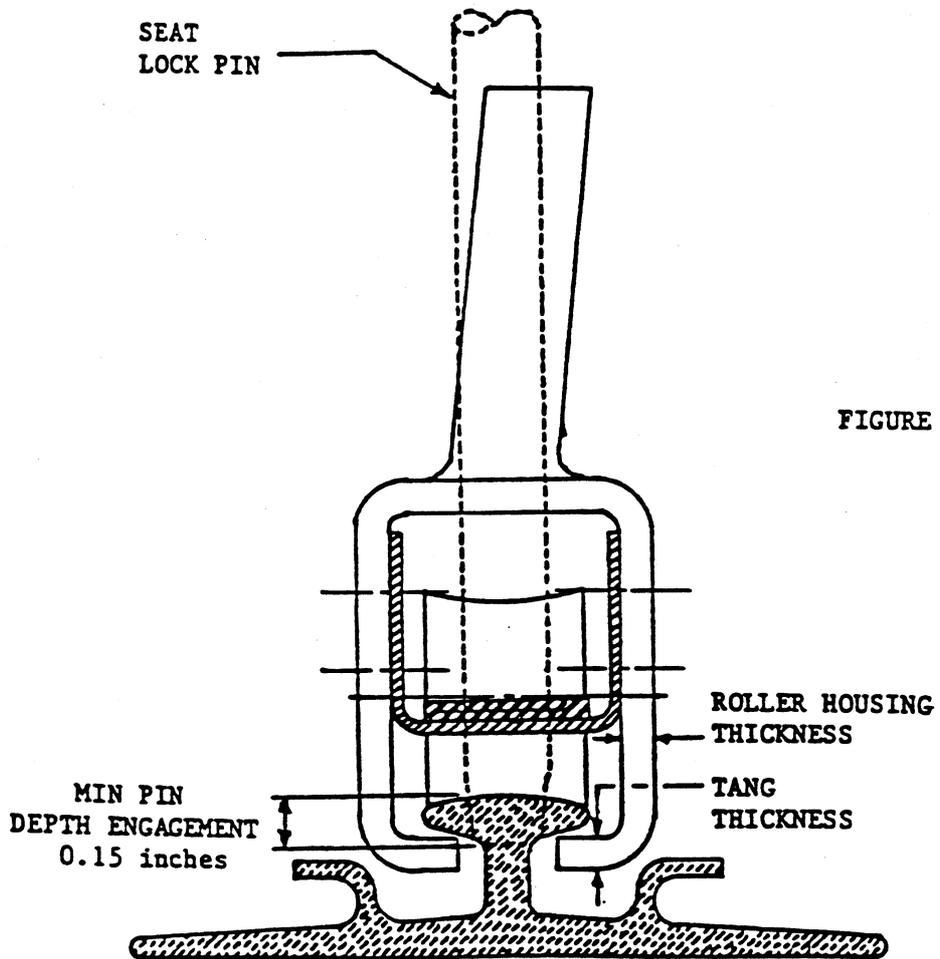
FIGURE 2

(3) Lift up on the forward edge of each seat to eliminate all vertical play. In this position, measure the depth of engagement of each seat pin. If the engagement of any pin is less than 0.15 inches (see Figure 2), prior to further flight, replace or repair necessary components to achieve a seat pin engagement of 0.15 inches or greater. If the track is worn, this dimension is measured from the worn surface, not the manufactured surface.

(5) Measure the wall thicknesses of the roller housing and the tang (see Figure 2). If the tang thickness has worn to less than 1/2 the housing thickness, prior to further flight, replace the roller housing.
