Swedish Airworthiness Directive (SAD)

SERVICE BULLETIN SAAB MFI SB 15.030

Number: SAAB MFI SB- 15.030
Date: 03 July 2024
Subject: LANDING GEAR - MAIN LANDING GEAR - INSPECTION OF THE
MAIN LANDING GEAR LEG CRADLES
Mod. No. -

LANDING GEAR - MAIN LANDING GEAR - INSPECTION OF THE MAIN LANDING GEAR LEG CRADLES

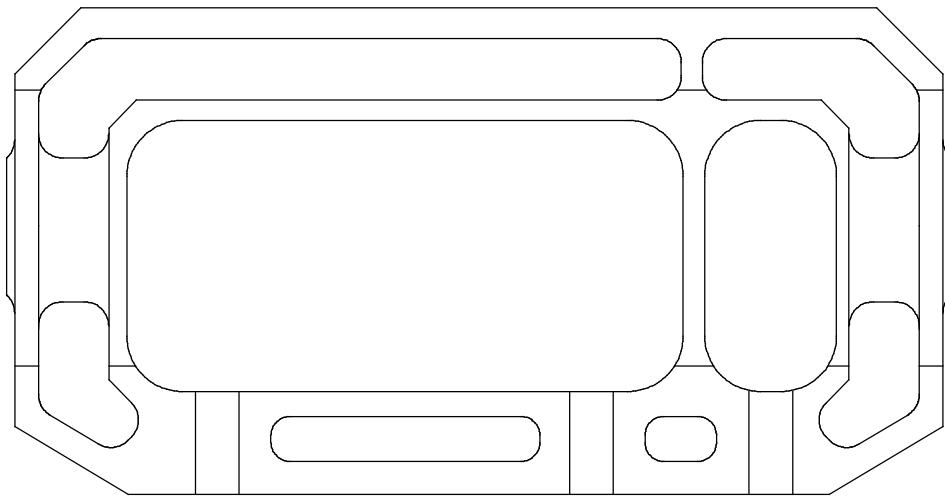
Cradles - Inspection
FIG. 4

- (3) Do a NDT inspection by penetrant or equal of the cradles (REF. FIG. 4).

- (5) If damage is observed, mark out the location and send the inspection form according to FIG. 4 to Saab AB.

- (1) If corrosion, fretting or cracks are found on a cradle or a tap, make a note of the findings and replace the cradle and/or the tap.
