## Swedish Airworthiness Directive (SAD)

<b>Subject / Reason:</b>	Cracks have been found in the Elevator Bearing Bracket P/N 5802215-001
<b>Applicability:</b>	SAAB-MFI 15-200/200A
<b>Revision:</b>	1
<b>Action:</b>	Mandatory. First visual and NDT inspection or Eddy Current as an additional inspection method to be performed on aircraft with more than 5000 Flight Hours accumulated and then repeated every 1500 Flight Hours. Aircraft with more than 5000 Flight Hours accumulated shall perform the first inspection within 200 Flight Hours from release of SAAB Service Bulletin, SB 15.029, Revision 1.
<b>Implementation:</b>	At the latest December 31 2024
<b>Supporting documentation:</b>	SB: SAAB--MFI SB 15.029, REVISION 01, 30 SEPTEMBER 2024, "ELEVATOR -- INSPECTION OF ELEVATOR BEARING BRACKET FOR CRACKS"
<b>Reference:</b>	Swedish Transport Agency decision, TSL 2024-7724
<b>Effective date:</b>	September 30 2024
<b>File reference no:</b>	TSL 2024-7724

**SERVICE BULLETIN SAAB-MFI SB 15.029**

**Subject:** ELEVATOR - INSPECTION OF ELEVATOR BEARING BRACKET  
FOR CRACKS

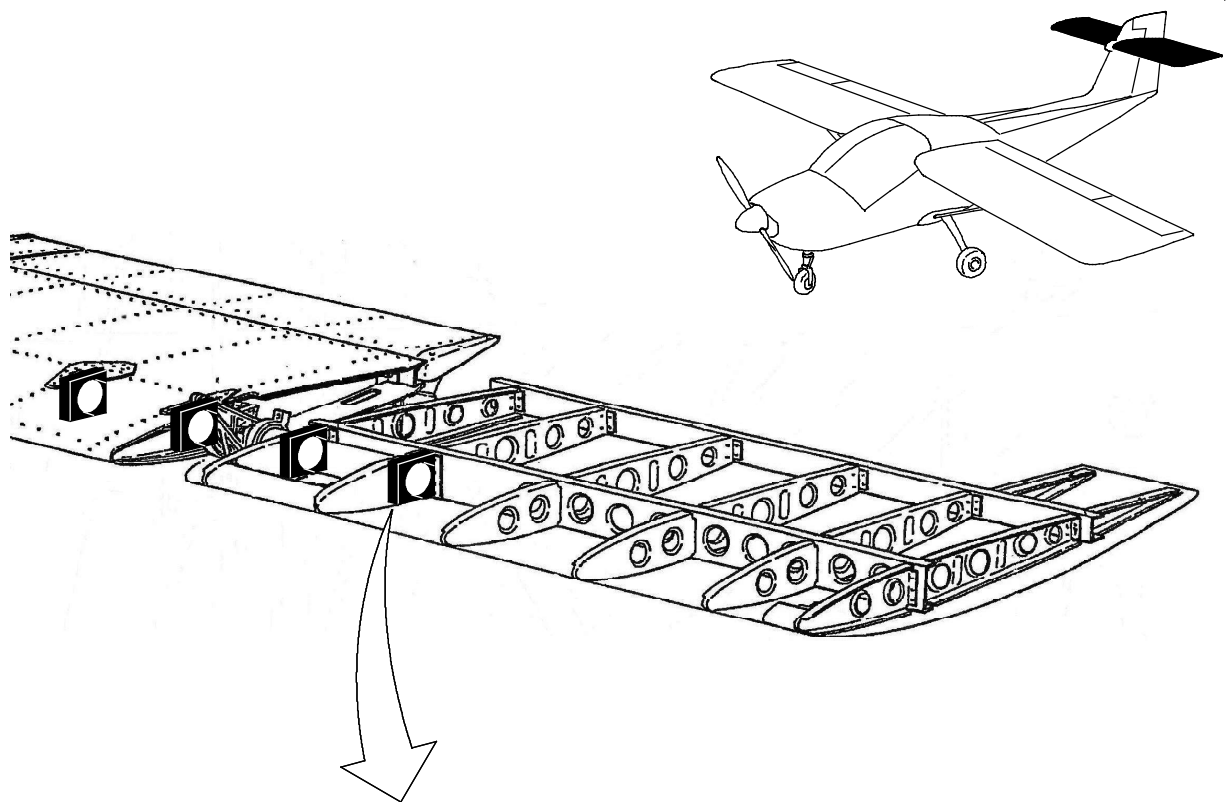
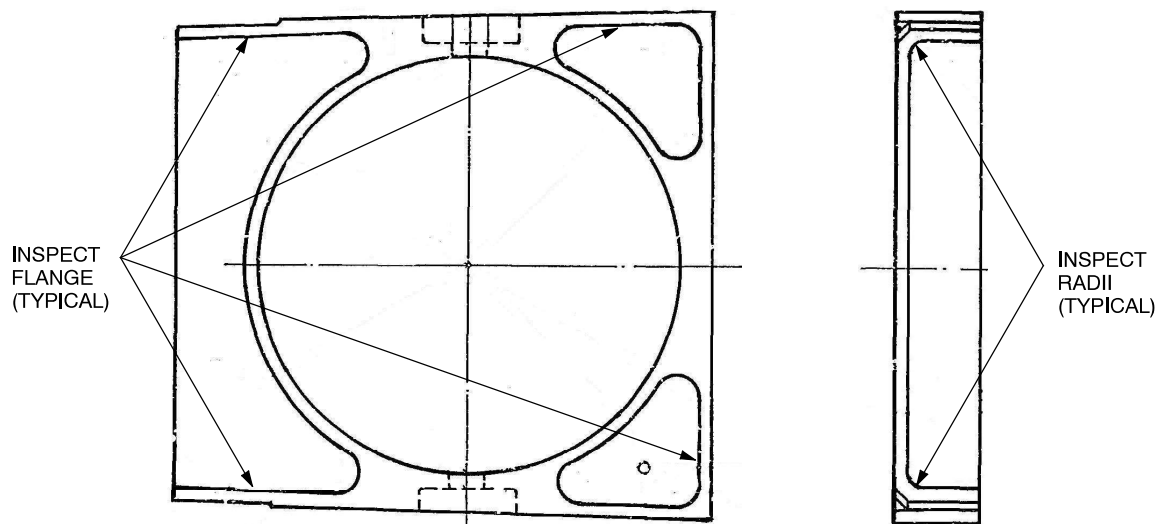
Bearing Bracket - Inspection  
FIG. 1

Cracks have been found in the Elevator Bearing Bracket P/N 5802215-001 (Ref. Parts Catalog T.O. 1T-17-4 figure 4-1 item 7) during inspections according to FLIP. The inspection point is only covered in the FLIP inspection program. The ordinary inspection maintenance requirement, ref T.O. 1T-17-6, does not cover inspection of the bracket of concern.

A broken elevator bearing bracket may lead to loss of an elevator on one side and subsequent loss of the aircraft.

- (1) Make sure the inspection areas (for visual and NDT inspection) are clean.
- (2) Do a detailed visual inspection of the inner and outer bearing brackets. Inspect for corrosion damages and cracks including the skins over the bearing brackets (REF. FIG. 1).
- (3) Do a NDT inspection by Eddy Current (preferred), penetrant or equal of the radii and around the fasteners/attachment holes of the outer and inner bearing brackets to ribs and spar (REF. FIG. 1).

BEARING BRACKET (TYPICAL 4PLCS)  
LH/RH INNER AND OUTER

- (1) If a corrosion damage or crack is found make a note of the findings and replace bearing bracket. For replacement of bearing bracket(s), please contact Saab for information: [SMA.techsupport@saabgroup.com](mailto:SMA.techsupport@saabgroup.com)
- (2) If only the damaged bearing bracket is replaced the next inspection shall be performed after 1 500 Flight Hours.
- (3) If both bearing brackets (outer and inner on one elevator side) are replaced, damaged or not, the next inspection on that elevator side shall be performed after 5 000 Flight Hours. The other elevator side shall be inspected after 1500 Flight Hours.
- (4) If all four bearing brackets (outer and inner on both elevator halves) are replaced, damaged or not, the next inspection shall be performed after 5 000 Flight Hours.
