Swedish Airworthiness Directive (SAD)

SERVICE BULLETIN SAAB- MFI SB 9/11- 2024

Number: SAAB-MFI SB 9/11-2024
Date: 11 December 2024
Subject: STRUCTURE - INSPECTION OF ENGINE VERTICAL BACK-UP
BEAMS FOR CRACK
Mod. No. -

STRUCTURE - INSPECTION OF ENGINE VERTICAL BACK-UP BEAMS FOR CRACK

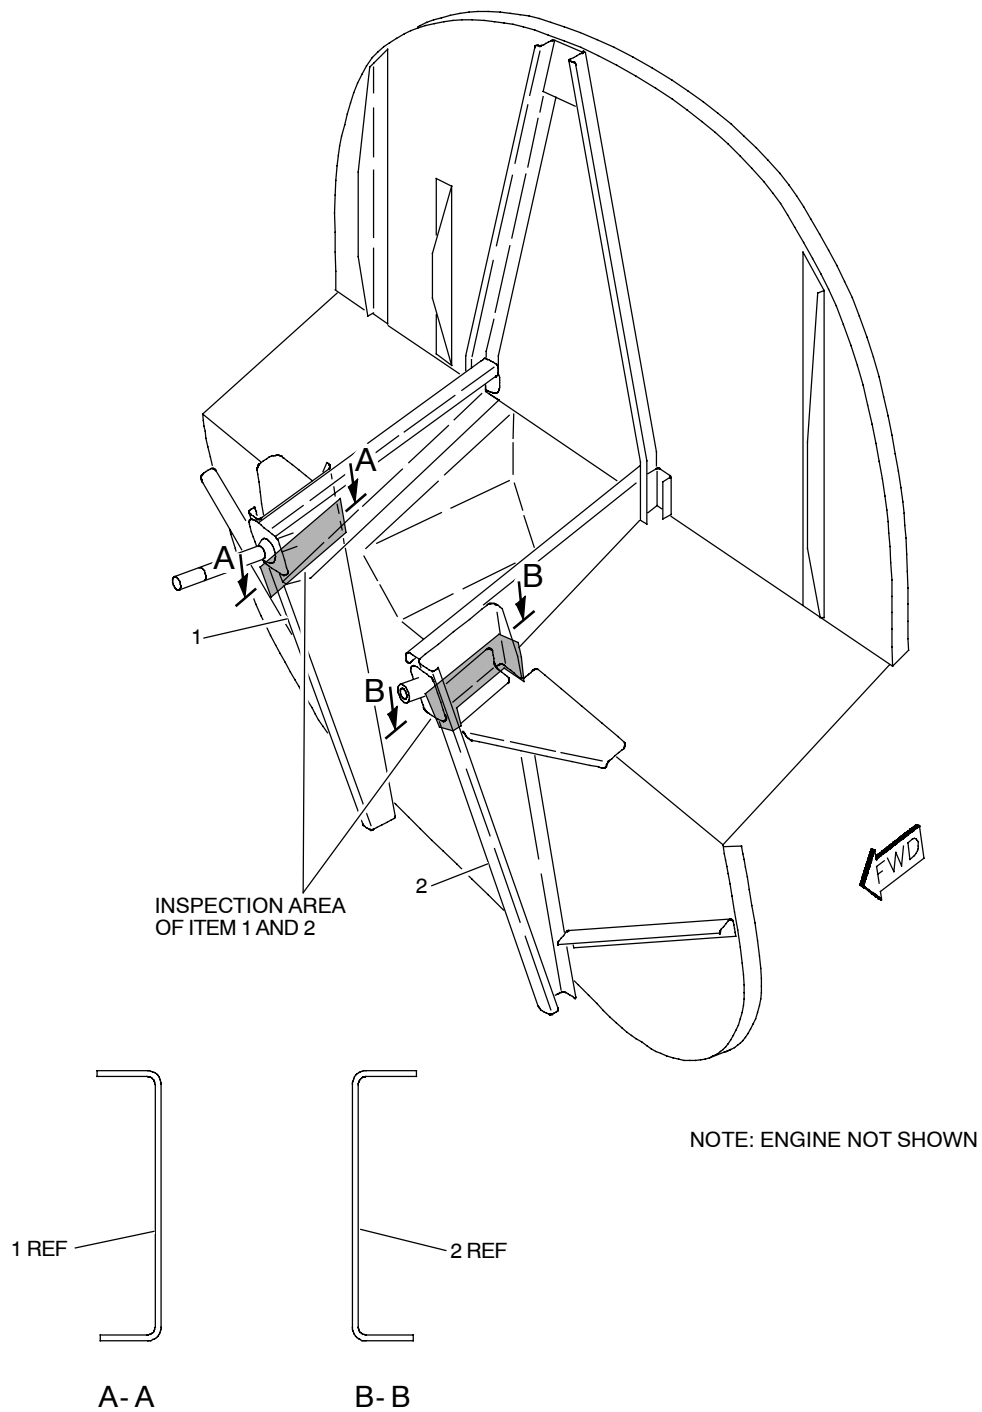
Engine Vertical Back-Up Beams - Inspection
FIG. 1

During maintenance, one of the engine vertical back-up beams (the beams) was found broken.

If one beam is broken, the other beam will be overstressed, jeopardizing the engine mounting to the fuselage.

- (1) Use mirror and a flashlight and do a visual inspection of the left and right engine vertical back-up beams (1 and 2) including attachments for crack or other damage.
- (2) If damage is observed, mark out the location and send the inspection form according to FIG. 2 to Saab AB.

- (1) If any crack or other damage are found, replace the damaged part.
- (2) To replace a damaged beam, the engine and the fuel pressure gauge must be removed. Contact Saab for further information:
SMA.techsupport@saabgroup.com
