TITEL: Kontroll av propellerregulatorns yttre oljerör för nötskador och sprickor.

GÄLLER: Alla Textron Lycoming fyrcylindriga kolvmotorer med yttre oljerör för propellerregulator monterad i motorns bakre apparatus.

LFS: 1991:16

90-04-06 R1 TEXTRON LYCOMING: Amendment 39-6427 as revised by Amendment 39-6915. Docket No. 89-ANE-21.

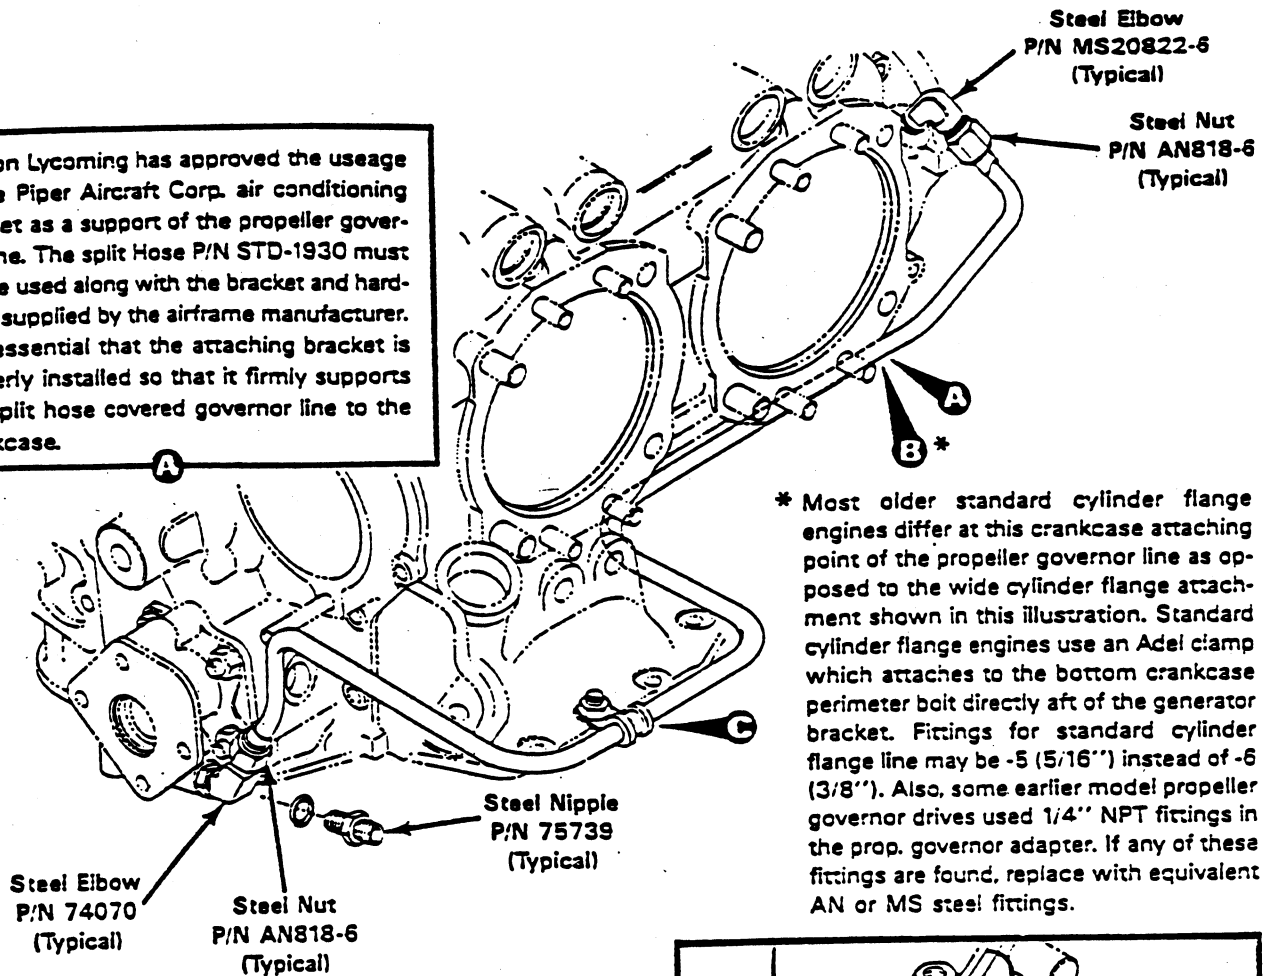
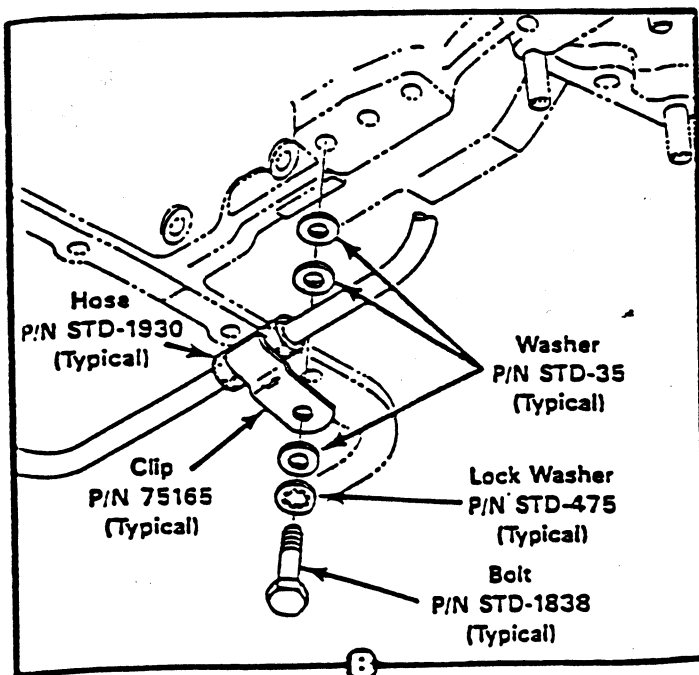
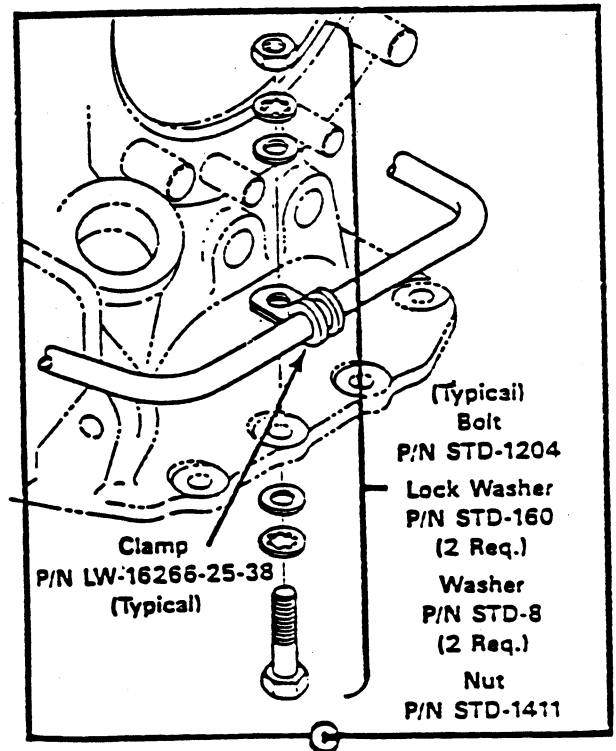
Figure 1. Propeller Governor Line Support

(1) Inspect the propeller governor external oil line for abrasions, cracks, and oil leaks along the length of the line and at the end attachment fittings. Inspect to determine that the two cushion type support clamps or clips are properly installed as shown in Figure 1 of Appendix 1 to this AD, and assure that sufficient clearances exist between the oil line and adjacent components.

Textron Lycoming has approved the usage of the Piper Aircraft Corp. air conditioning bracket as a support of the propeller governor line. The split Hose P/N STD-1930 must still be used along with the bracket and hardware supplied by the airframe manufacturer. It is essential that the attaching bracket is properly installed so that it firmly supports the split hose covered governor line to the crankcase.

* Most older standard cylinder flange engines differ at this crankcase attaching point of the propeller governor line as opposed to the wide cylinder flange attachment shown in this illustration. Standard cylinder flange engines use an Adel clamp which attaches to the bottom crankcase perimeter bolt directly aft of the generator bracket. Fittings for standard cylinder flange line may be -5 (5/16") instead of -6 (3/8"). Also, some earlier model propeller governor drives used 1/4" NPT fittings in the prop. governor adapter. If any of these fittings are found, replace with equivalent AN or MS steel fittings.

(2) If any leaks, chafing, or interference condition exists or if the two support clamps or clips are not properly installed, replace the governor oil line and its attachment end fittings with new parts even though the parts show no visible damage. Refer to Figure 1 in Appendix 1 to this AD, for parts identification, line routing, and location of support clamps or clips. The fittings in the engine case and governor must be replaced if they are damaged or are made of aluminum.

(b) At the next engine overhaul or anytime the governor oil line is removed for any reason, whichever occurs first, but no later than May 1, 1992, remove any governor oil line assembly having integral aluminum connecting nuts and reinstall an oil line assembly with corresponding steel connecting nuts. Replace any engine case/governor aluminum fittings with corresponding steel fittings as shown in Figure 1 of Appendix 1 to this AD.

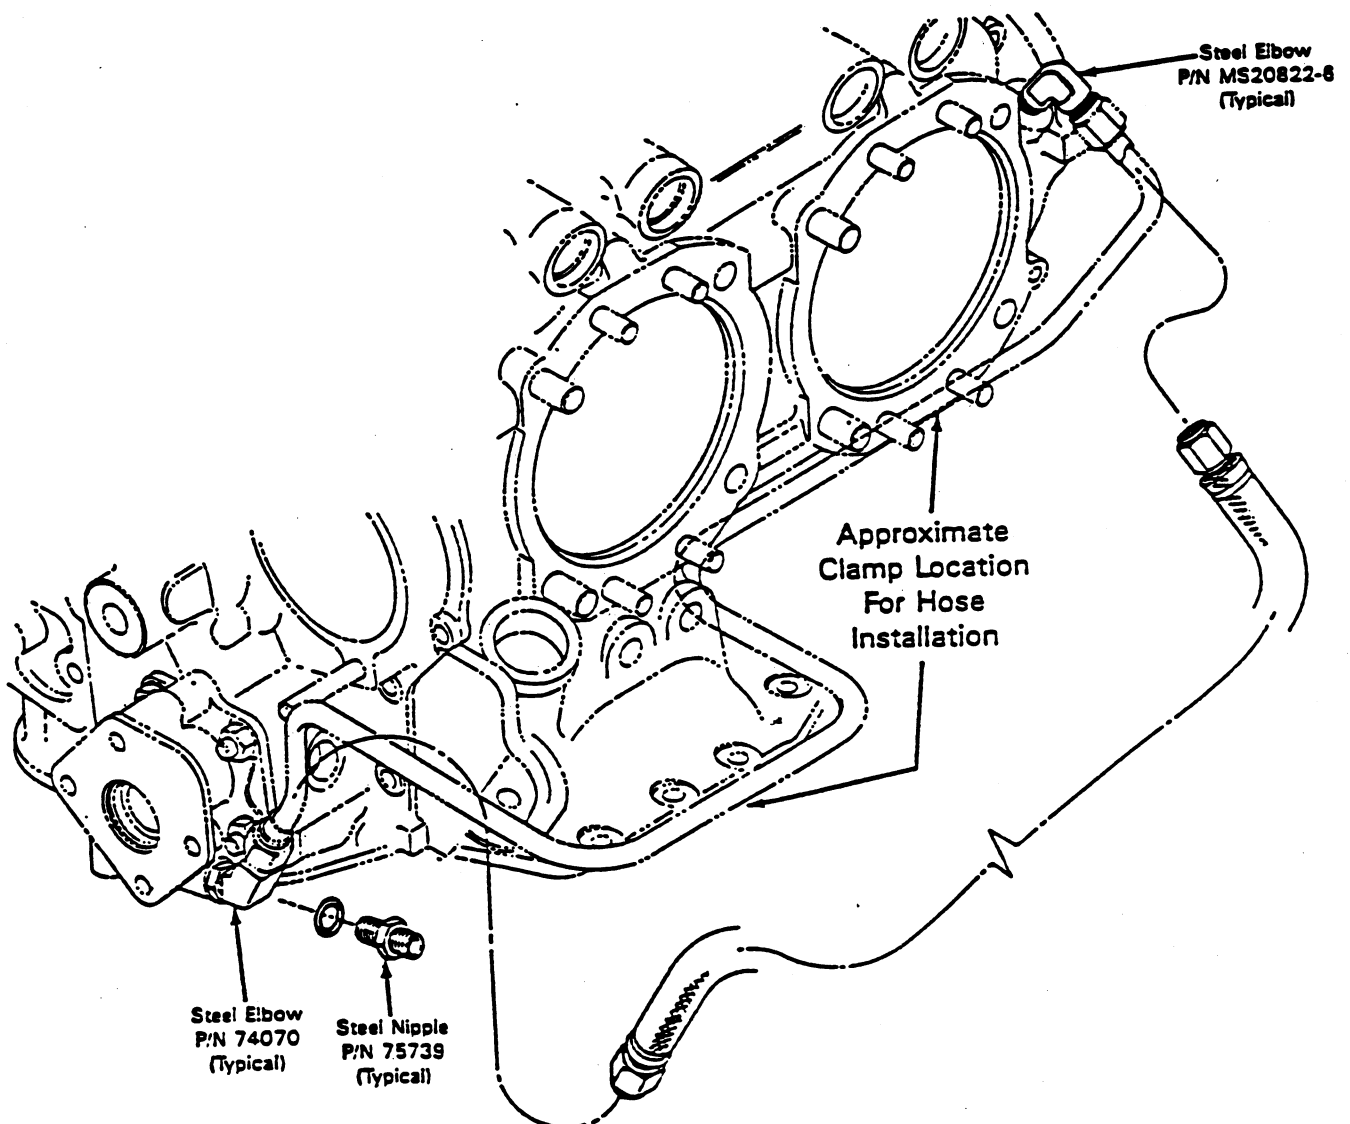
Figure 1. Routing, Fittings and Clamping Detail

If -5 (5/16") fittings have been installed on some standard cylinder flange crankcase model engines, the propeller governor drive fitting and front crankcase fitting must be changed to the appropriate steel fitting to accommodate the new -6 (3/8") line. When re-installing new stainless steel tube assembly, appropriate -5 steel fittings must be re-installed.

(c) An optional method of compliance with paragraph (a)(2) and (b) is the installation of steel fittings and a fire resistant flexible hose assembly which meets the standards in FAA Technical Standard Order TSO-C53a Type D, and is installed in accordance with Appendix 2 of this AD.

- a. Determine proper hose length as required for your particular installation.
- b. No sharp bends are permissible. Ascertain that no "kinks" exist while routing and clamping hose.
- c. Hose must not be routed near a heat source, such as any portion of the exhaust system.
- d. Hose is to be clamp supported to the engine (not to an airframe component) at a minimum of two locations.
- e. No clamping to cylinder head drain back tubes is allowed.
- f. After installation is complete, ensure that hose is not pinched. Make certain that engine motion during startup and shutdown does not pull or pinch the hose.
