TITEL: Kontroll/modifiering av stjärtrotordrivning

90-17-02 ENSTROM HELICOPTER CORPORATION: Amendment 39-6688.
Docket No. 90-ASW-28.

90-17-03 ENSTROM HELICOPTER CORPORATION: Amendment 39-6686.
Docket No. 83-ASW-39.

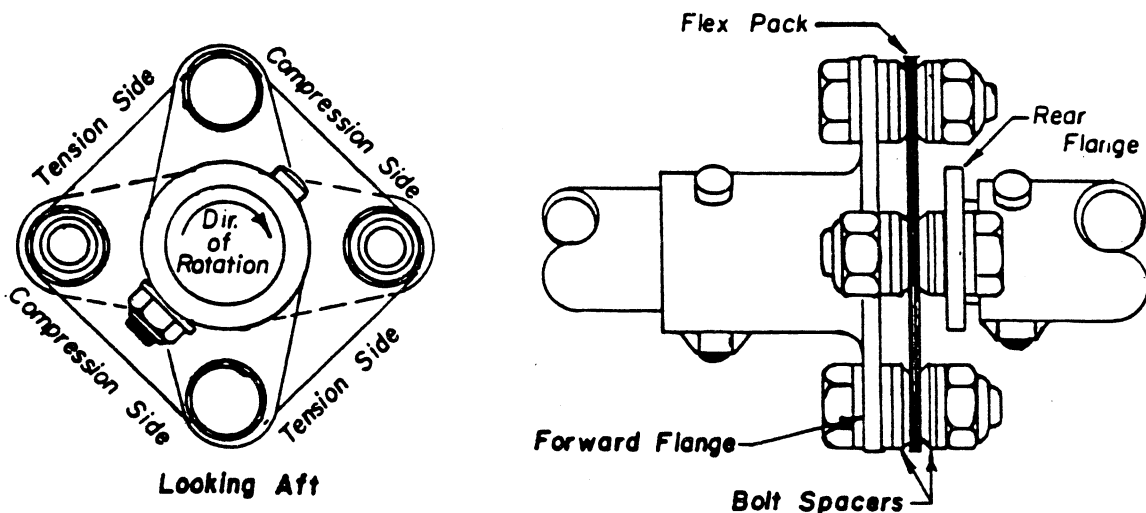
FIGURE 1
 Tension Sides Versus Compression Sides
 Tail Rotor Drive Shaft Coupling Installation.
 Rear coupling shown; forward coupling similar.
NOTE: Tie-wraps eliminated for clarity.

(1) Locate the tension and compression sides by comparing the couplings to Figure 1.

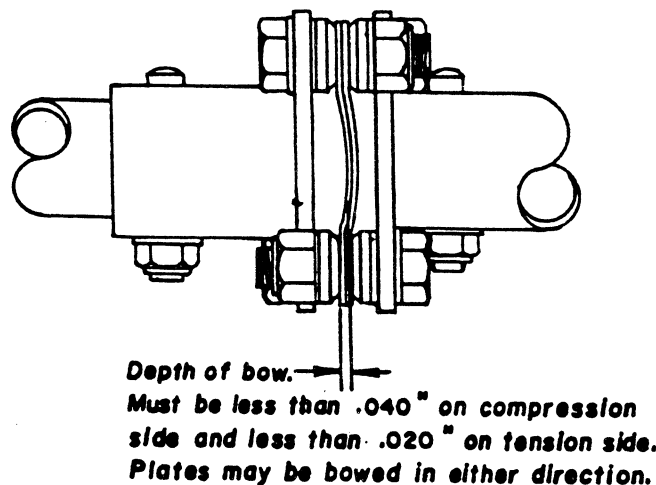
Figure 2 - Acceptable Limits of Bowed Flex Packs.

(2) Inspect the couplings for flex pack distortion in the shape of a bow. Compare any distortion to the acceptable limits shown in Figure 2.

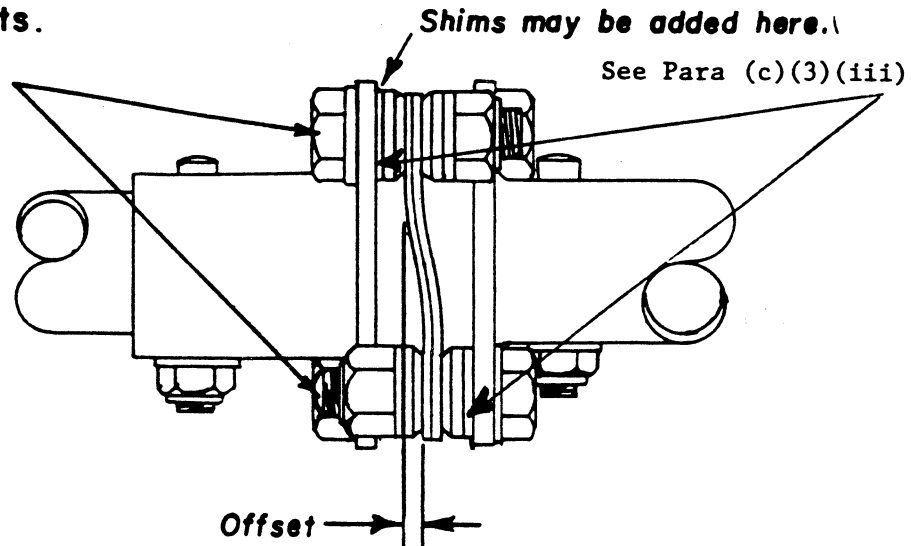
Figure. 3 - Acceptable Limits of Flex Packs with Offset Bends.

(3) Inspect the couplings for flex pack distortion in the shape of an offset bend. The acceptable limits shown in Figure 3 are as follows:

(i) The offset on one set of plates must not exceed 0.015 inches.

(ii) The maximum difference in offset from side to side (one pair of bolts to the other pair) must be less than 0.007 inches.

(iii) The maximum allowable shim thickness is 0.072 inches (not including bevel washers).

Must be less than .015" on both sides (See Para (c)(3)(i))

**.When the flex pack is replaced,
shims may be added at the bolt spacers
as indicated to align the new flex pack.**

Torque bolts to 75 in.lbs.

**CAUTION: Do not add shims or washers between
the flex pack and the beveled washers.**

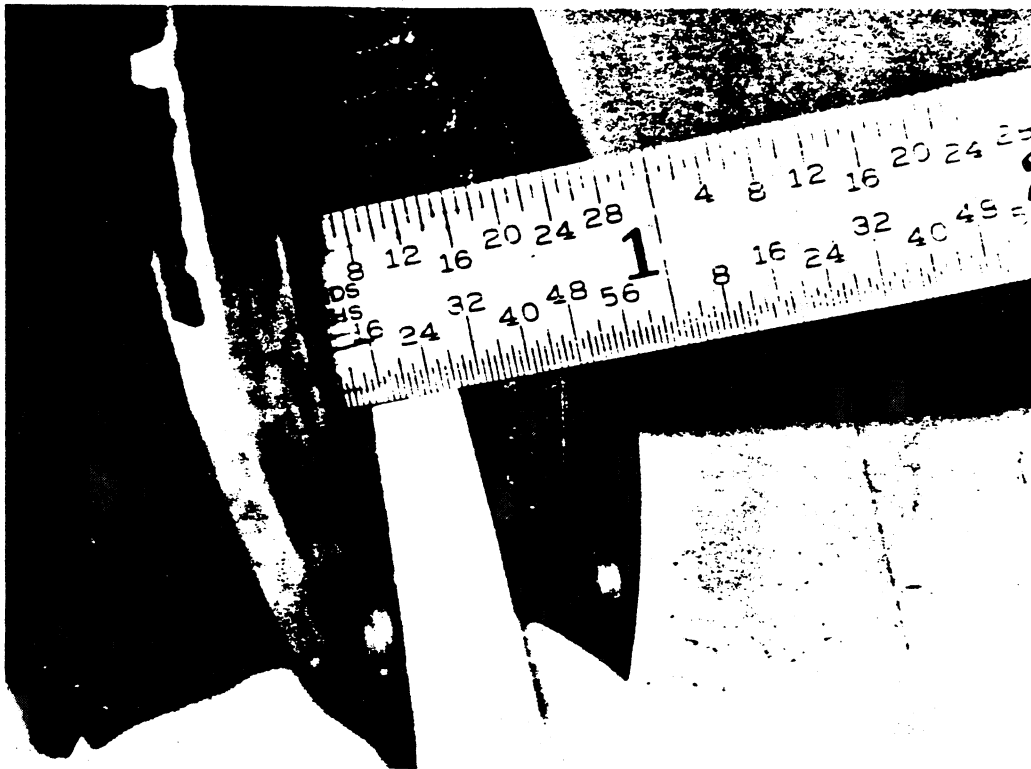
Figure 1. Checking inner spline wear on coupling.

(i) Visually and dimensionally inspect for wear and proper tooth contact in accordance with Figure 1. Measure the height of the spline crown shown in Figure 2 at the center with a steel scale (having graduations of 1/100 inch) and a 10 power glass. Replace with airworthy parts any couplings that have a center crown height of less than 0.015 inch.

NOTE: Tooth wear is measured by placing a 6 inch steel rule parallel to the crown at the top edge of the driven side. A piece of .125 x .010 inch shim stock is then placed between the tooth and the rule, and pressing the rule against the tooth, check if the shim can be removed. If the shim slips out, the coupling is to be rejected and replaced with an airworthy component.

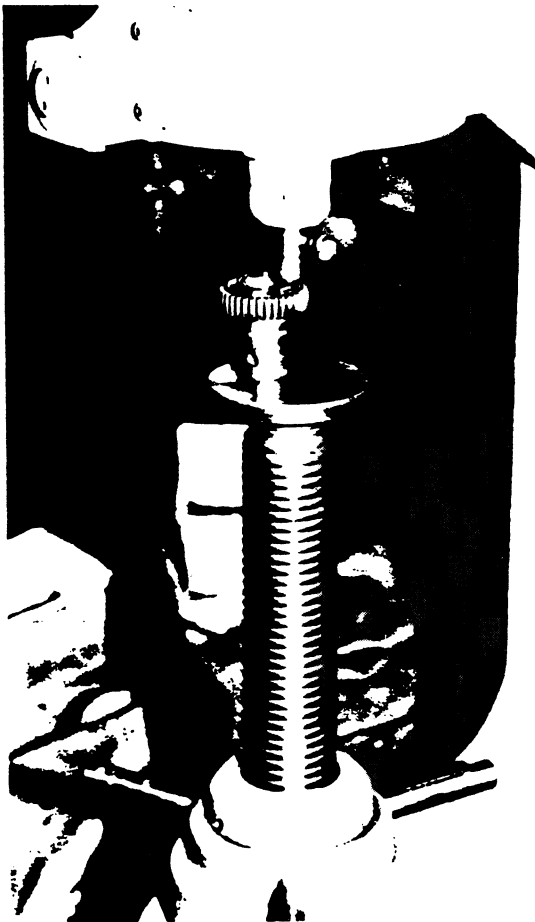
Figure 3.
Checking hardness on male
portion of coupling.

(ii) Test both the male and female portions of the coupling for material hardness. Test the male portion on the inner circular face as shown in Figure 3. Test the end of the stud of the female portion as shown in Figure 4. Use three readings and average the readings. Replace with airworthy parts any couplings which have average readings below 25 on the Rockwell "C" scale.
