**TITEL:** Kontroll av bultar i huvudrotorväxel

**GÄLLER:** Alla MDHC modell 369D, 369E och 369F/FF

## AIRWORTHINESS DIRECTIVE

**90-24-07 MCDONNELL DOUGLAS HELICOPTER COMPANY (MDHC):**

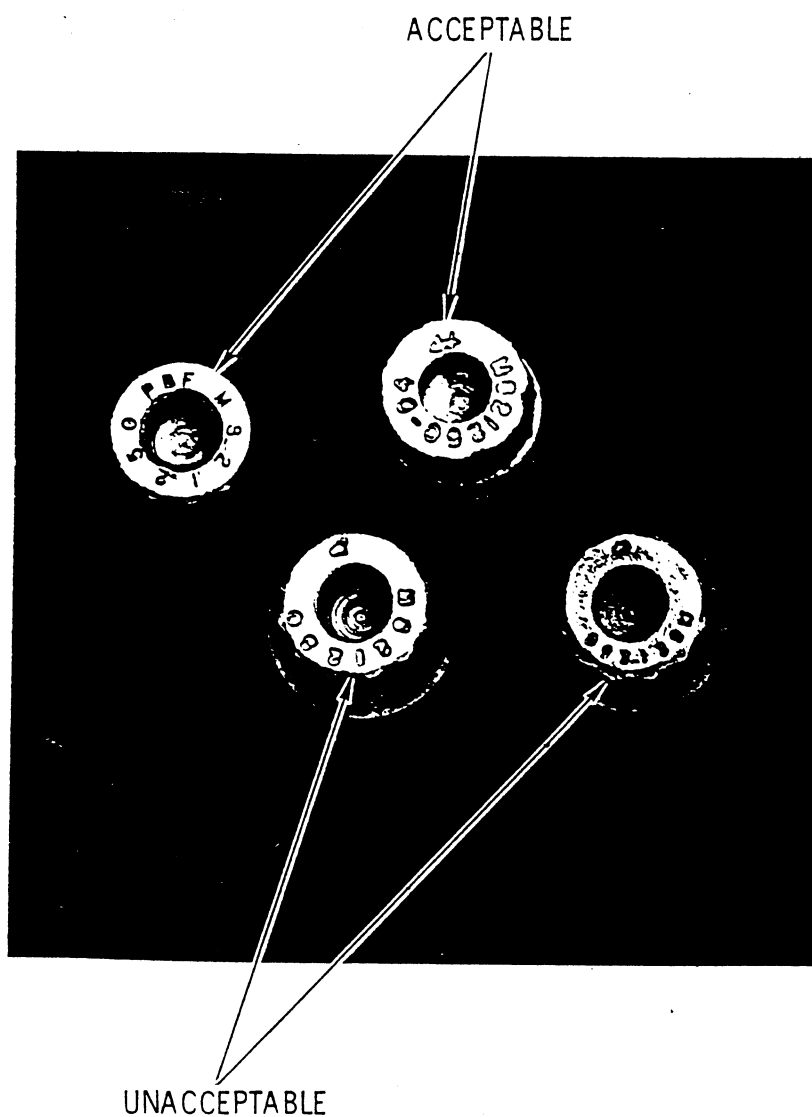
Figure 1. Inspection/Definition of Bolt Heads.

(a) Within the next 300 hours' time in service after the effective date of the AD or at the next annual inspection or the next time the transmission is removed, whichever occurs first, after the main rotor transmission is removed inspect the MS21250-04036 bolts which retain the debris cover, P/N 369D25174. Remove any bolts with the head inscription shown as unacceptable in Figure 1, and replace with MS21250-04038 bolts, which have a length of 2.887 plus/minus 0.010 inch.

(b) Inspect the thread protrusion of all bolts. Remove any bolt which does not protrude through the H14-4 nut for a length equivalent to two full threads (0.071 inch minimum), including the chamfer. Replace removed bolts with MS21250-04038 bolts. Torque the bolts to 50-70 inch pounds. Verify that the bolts protrude through the nut for a length equivalent to two full threads (0.071 inch minimum), including the chamfer. If more than four threads protrude through the nut, add AN960C416L or AN960C416 washers under the nut as required. Remove and reinstall parts in accordance with the manufacturer's instructions.

(c) Apply a white dot to the main transmission data plate to indicate that the transmission has been inspected and reworked in accordance with the manufacturer's instructions, and record compliance with this AD in the rotorcraft log book.
