TITEL: Kontroll av stjärtrotorbladens rotfästen för sprickor

GÄLLER: Alla MDHC Modell 369

AIRWORTHINESS DIRECTIVE

91-08-02 MCDONNELL DOUGLAS HELICOPTER COMPANY (MDHC) (HUGHES):
Amendment 39-6963. Docket No. 90-ASW-53.

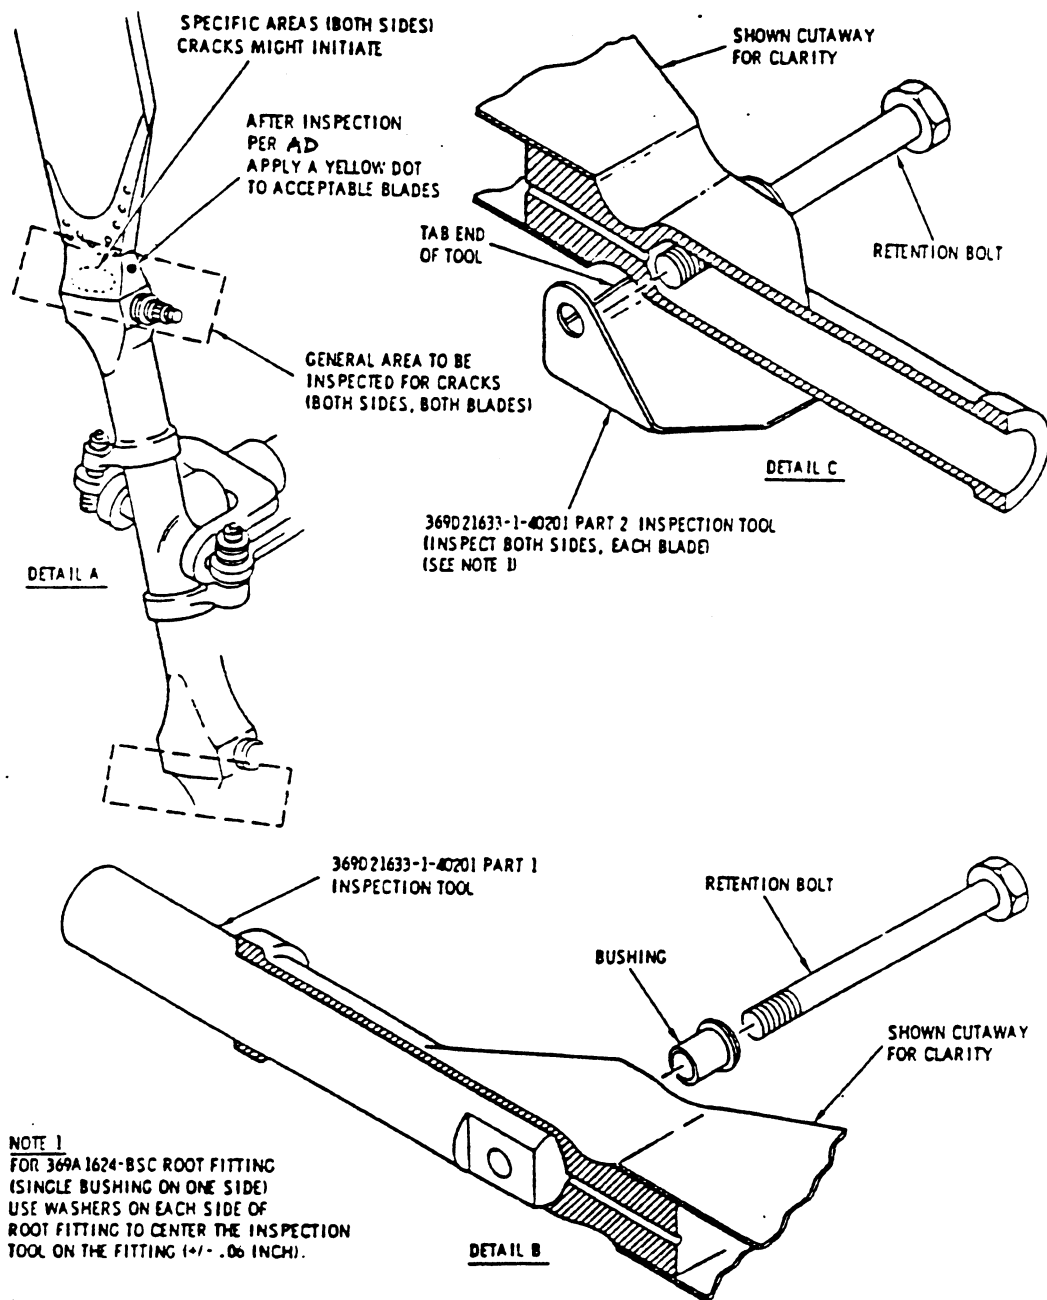
Figure 1. Inspection of Tail Rotor Blade Root Fitting.

To detect or prevent cracks in the tail rotor blade root fitting, which could result in tail rotor blade failure and subsequent loss of the tail rotor blade, accomplish the following:

(c) Within 8 hours time in service, after the effective date of this AD and, thereafter, prior to the first flight of each day, conduct a check of each tail rotor blade that fits the criteria outlined in paragraph (a). Visually check both sides of the tail rotor fitting for cracks in the area shown in Figure 1, Detail A. Replace any cracked blades with airworthy parts before further flight.

(viii) Apply a yellow dot to airworthy tail rotor blades on the trailing edge of the root fitting approximately one-half inch outboard from the bushing. (See Figure 1, Detail A.) Record compliance by part number and serial number in the helicopter log book.
