TITEL: Färgmärkning av hävarm / styrlina i skevroderssystemet

GÄLLER: PA-31 alla modeller alla S/N.

LFS: 1993:3

92-27-05 PIPER AIRCRAFT CORPORATION: Amendment 39-8438. Docket No. 91-CE-14-AD.

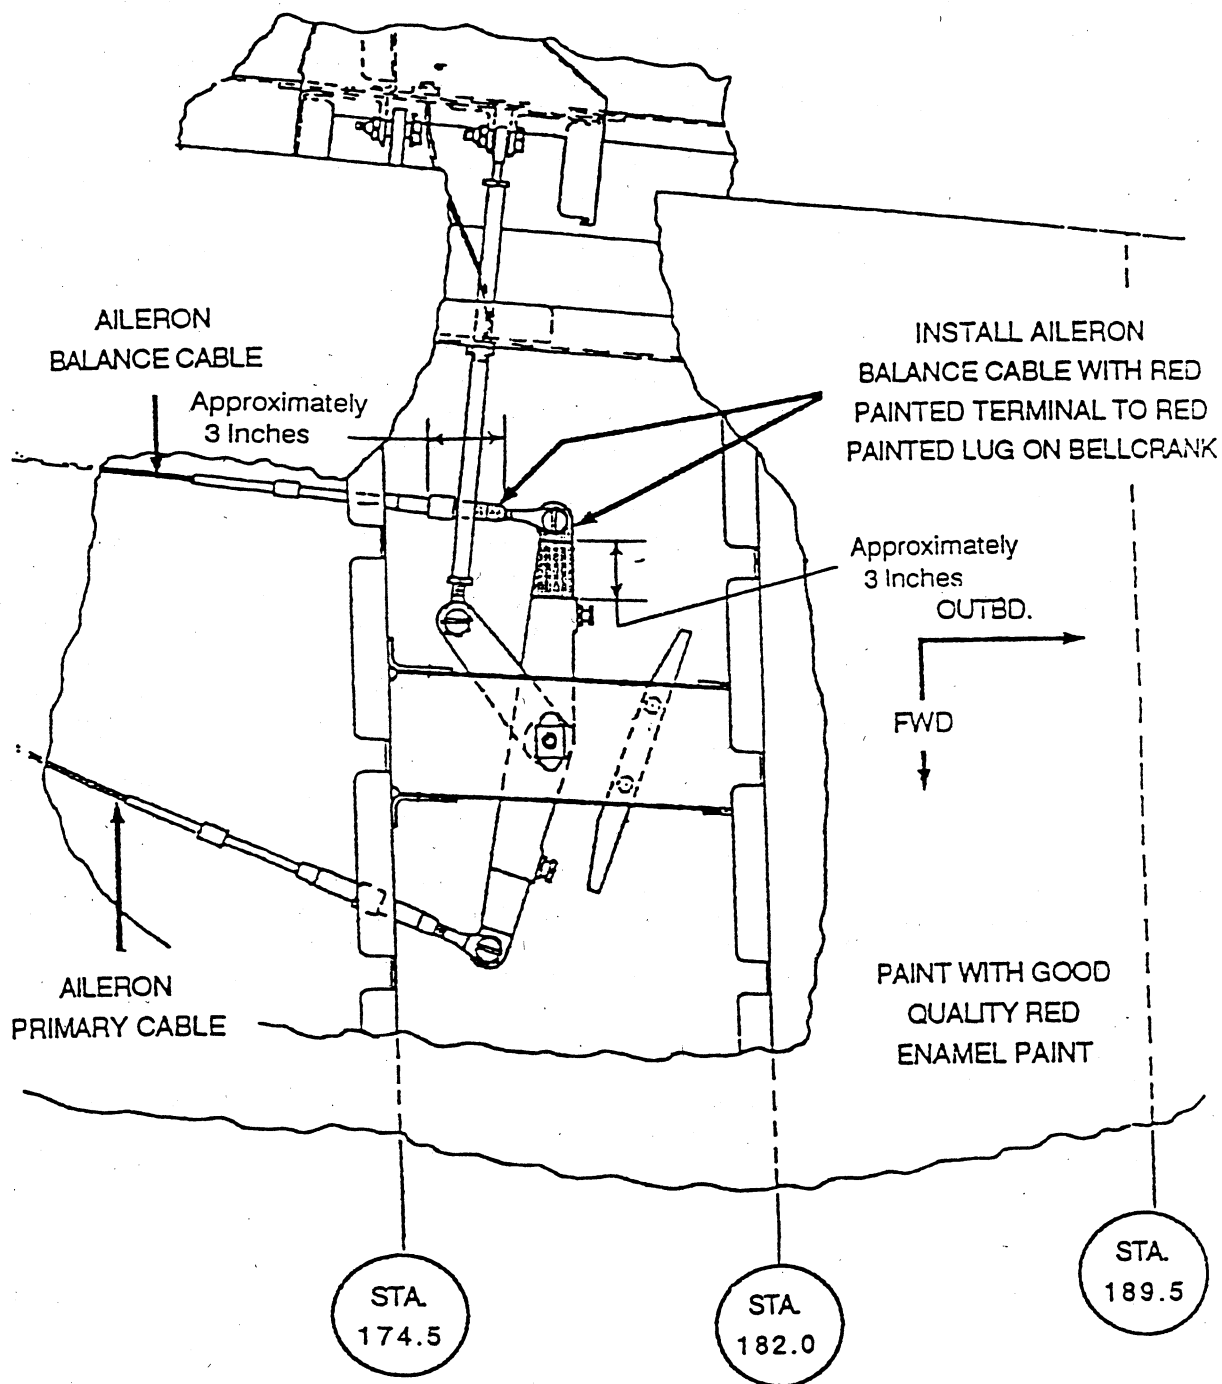
FIGURE 1
VIEW LOOKING THRU TOP WING SKIN (LEFT WING)
RIGHT WING OPPOSITE

To prevent improper connection of the aileron control systems, which could result in loss of lateral control of the airplane, accomplish the following:

ÅTGÄRD: Utför färgmärkning i enlighet med figur 1 i bifogad kopia av FAA AD 92-27-05.

(a) Using red enamel paint, color code the aileron balance cable and the bellcrank lug of both aileron control systems in accordance with Figure 1 of this AD.
