TITEL: Kontroll av stötstång i bakkroppen för höjdroder

GÄLLER: PA31, PA31A och PA31T alla modeller och S/N.

93-24-02 R1 PIPER AIRCRAFT CORPORATION: Amendment 39-8810 which revises Amendment 39-8751. Docket No. 93-CE-57-AD.

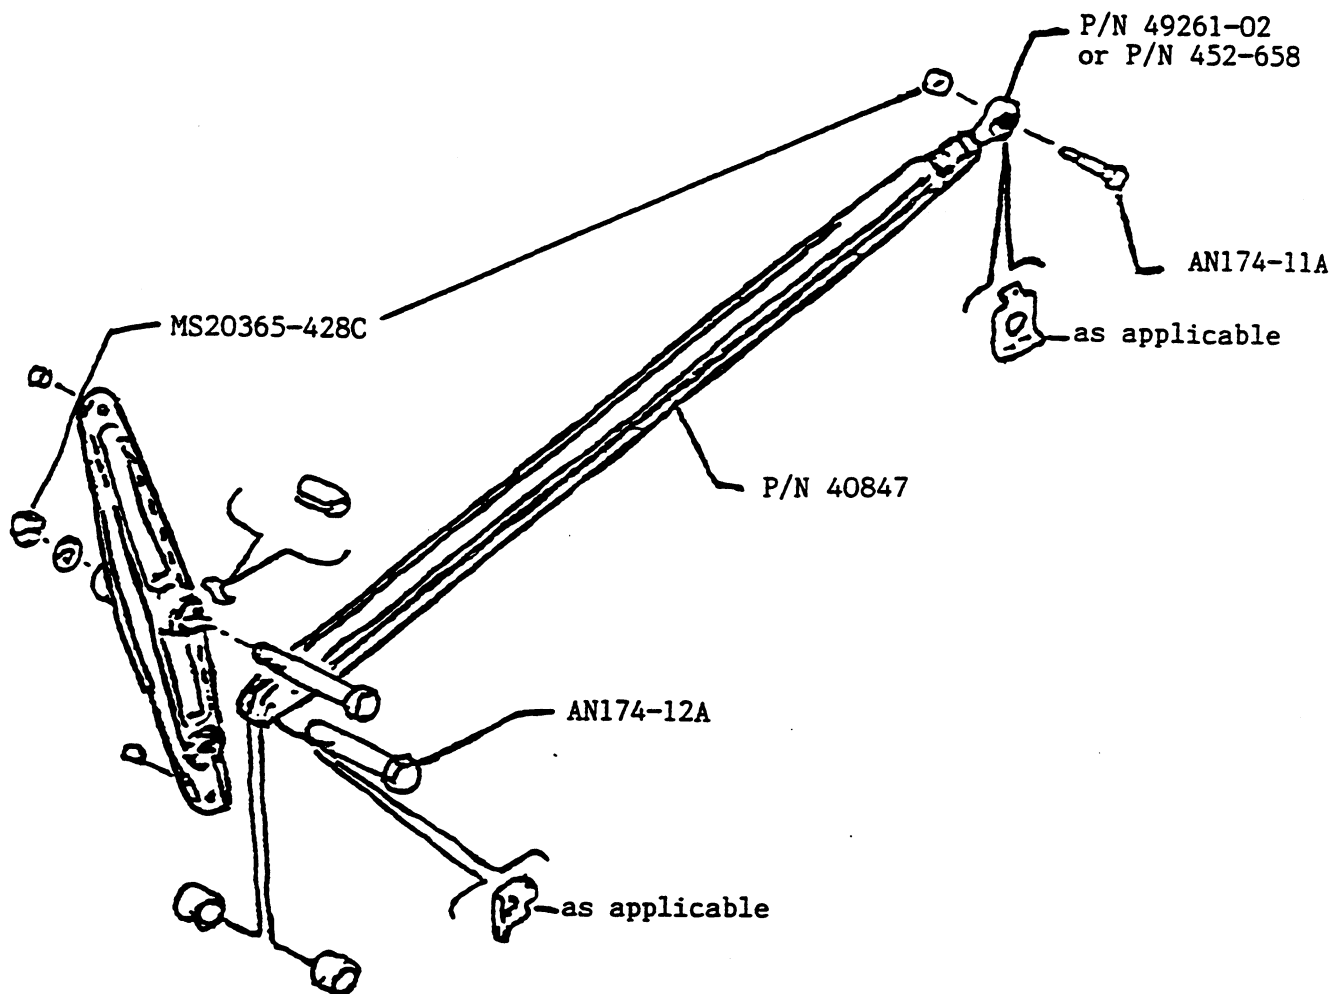
FIGURE 1

(4) Inspect, using FAA-approved magnetic procedures, the rod end shank and threads for cracks. If found cracked, prior to further flight, replace the rod end with part number (P/N) 49261-02 or P/N 452-658.

(5) Visually inspect the bearing in the rod end for wear and free movement. If wear is found or the bearing will not move, prior to further flight, replace the rod end with P/N 49261-02 or P/N 452-658.

(6) Inspect, using a 10X magnifying glass, the forward attach holes in the pushrod for cracks, corrosion, or elongation. If cracks, corrosion, or elongation is found, prior to further flight, replace the pushrod with P/N 40847-00, 40847-04, or 40847-07, as applicable.

(7) Visually inspect the forward and aft attach area to ensure that both a forward bolt, P/N 402 311 (AN 174-12A), and an aft bolt, P/N 402 317 (AN 174-11A), are installed. If either one of these bolts is not installed, prior to further flight, install the applicable bolt or replace the existing bolt with one of the applicable part number.

NOTE 1: Figure 1 of this AD illustrates the elevator assembly and the specific areas that are to be inspected.
