**TITEL:** Byte av bult och justeringsbrickor för övre fällstöttans infästning

**GÄLLER:** PA 34 alla modeller och S/N.

**93-24-14 PIPER AIRCRAFT CORPORATION: Amendment 39-8762; Docket No. 93-CE-17-AD.**  
Applicability: PA34 Series airplanes (all models and serial numbers), certificated in any category.

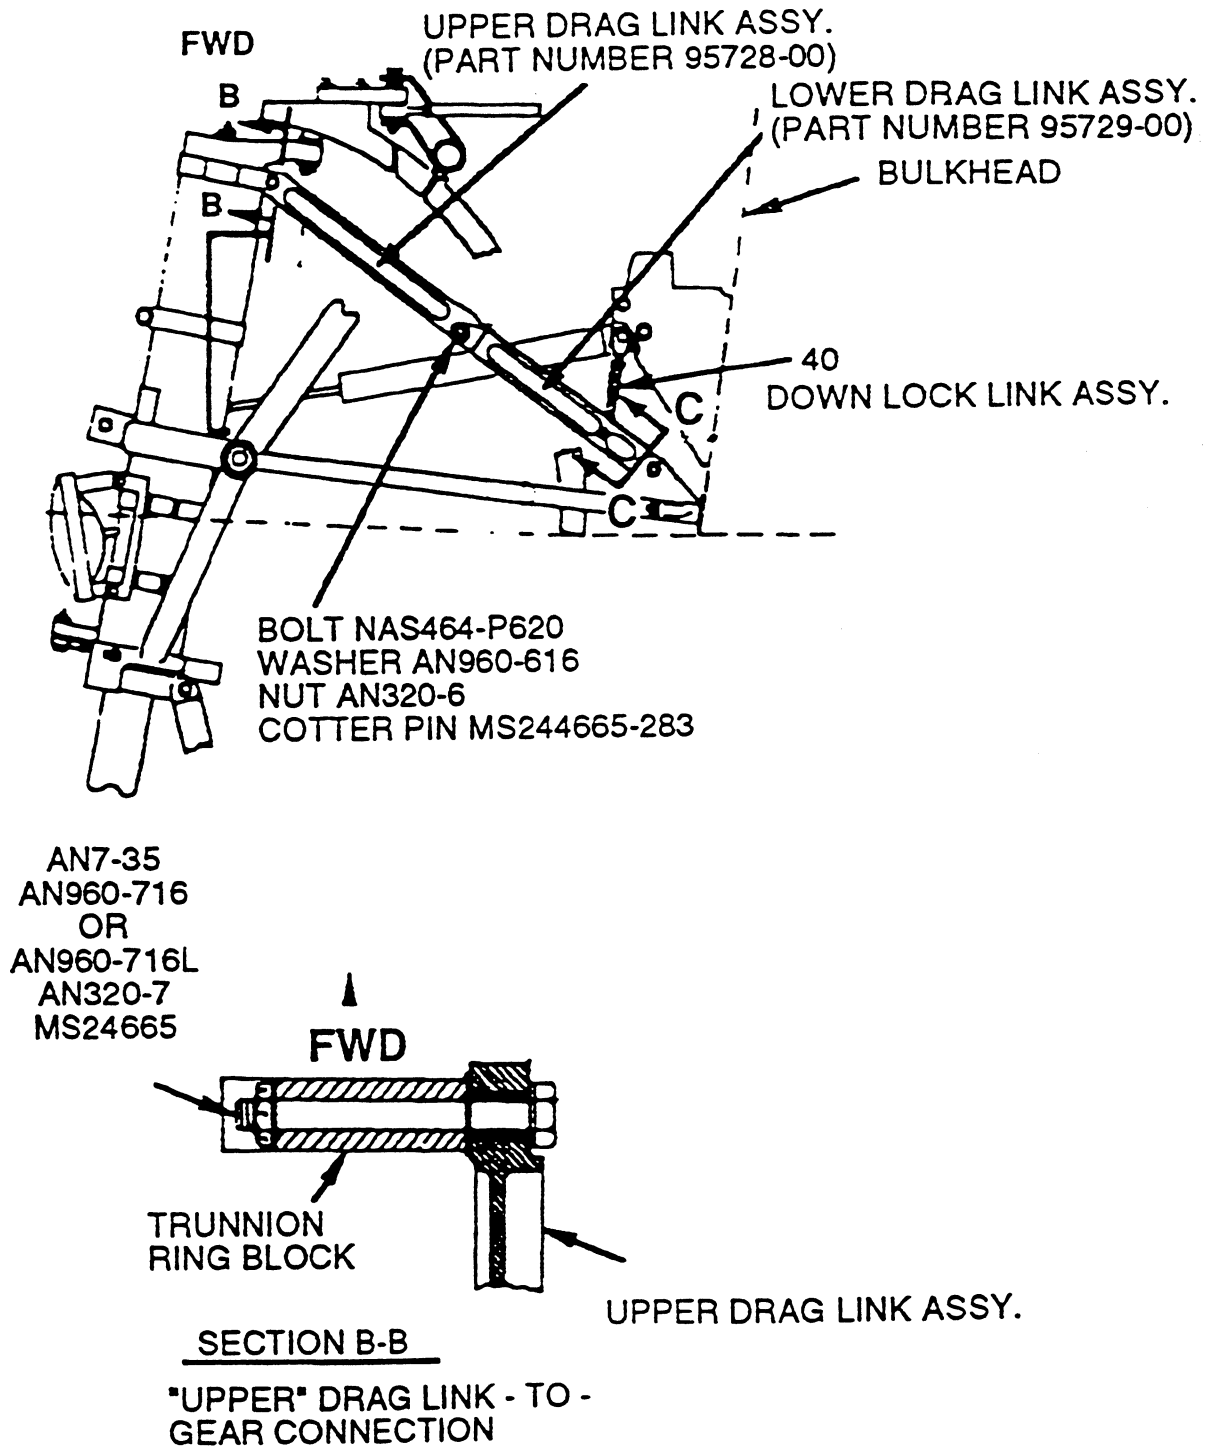
To prevent the nose landing gear from collapsing because of failure of the bolt that connects the upper drag link to the nose gear trunnion, which could lead to airplane damage, accomplish the following:

(a) Replace the bolt and stack up that connects the upper drag link to the nose gear trunnion with new parts of the following in accordance with Figure 1 of this AD:

- (1) Piper part number (P/N) 400 274 (AN7-35) bolt.
- (2) Piper P/N 407 591 (AN960-716L) washer, as applicable.
- (3) Piper P/N 407 568 (AN960-716) washer, as applicable.
- (4) Piper P/N 404 396 (AN320-7) nut; and
- (5) Piper P/N 424 085 cotter pin.
