TITEL: Justering av varvtalsregulatorns minimumstopp (Ground Idle)

GÄLLER: MU-2B modeller och S/N angivna i bifogad kopia av FAA AD 94-11-04.

LFS: 1994:22

94-11-04 MITSUBISHI HEAVY INDUSTRIES, LTD.: Amendment 39-8920; Docket No. 94-CE-09-AD.

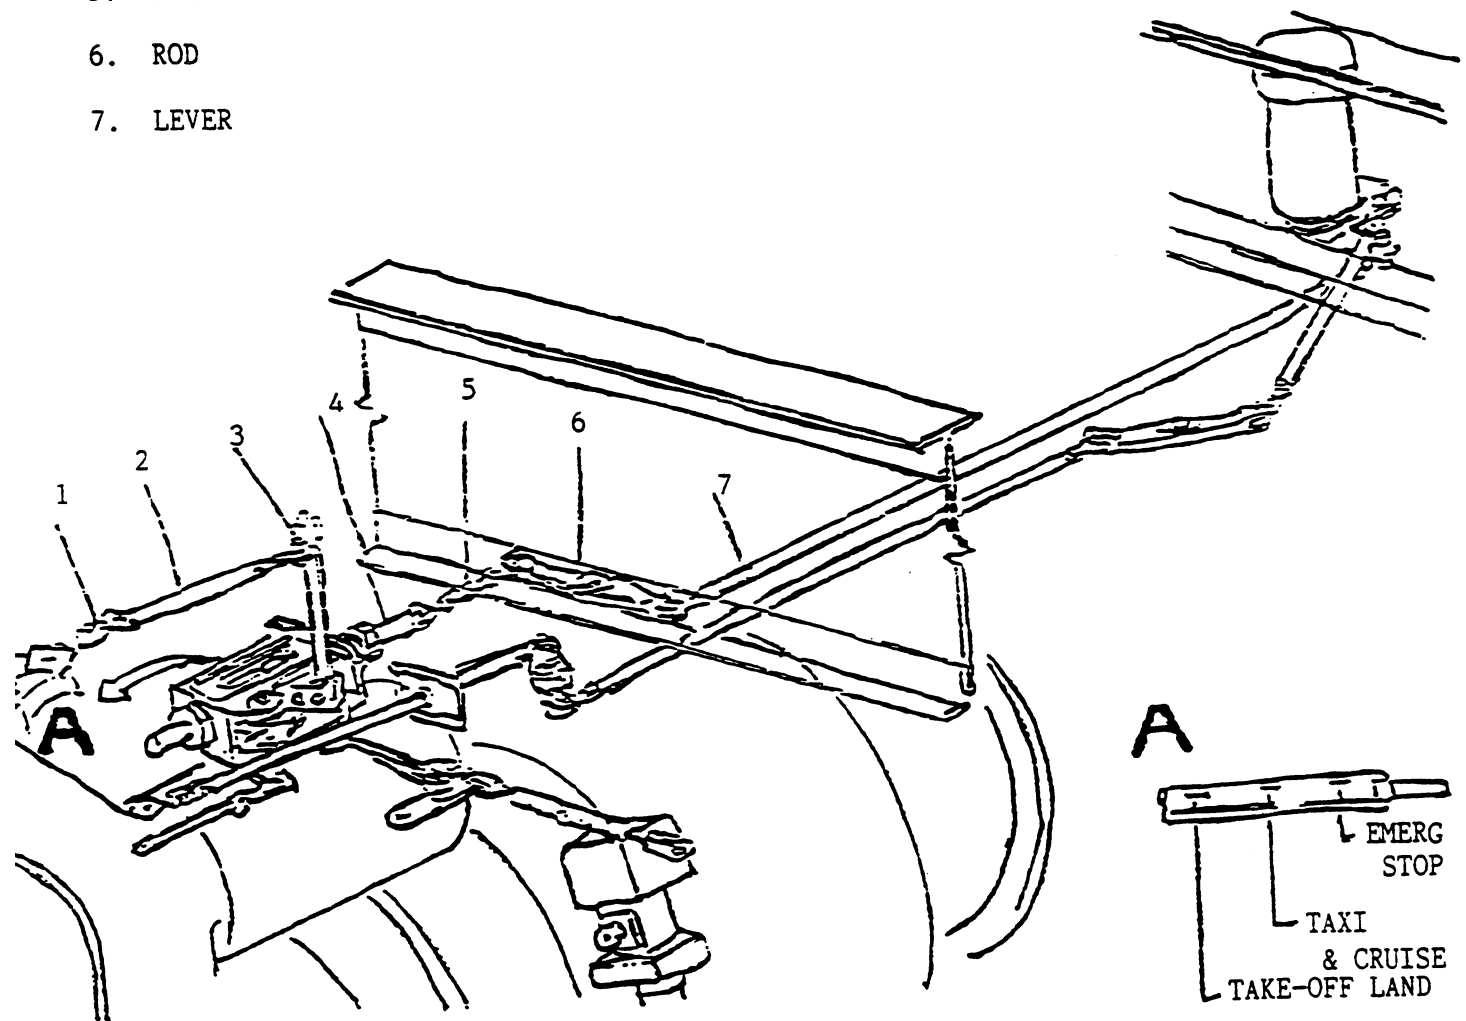
FIGURE 1

To prevent propeller hub arm assembly failure because of high vibration frequencies during ground idle speed and possible separation of the propeller from the airplane, which could result in loss of control of the airplane, accomplish the following:

1. ROD
2. LEVER
3. CYLINDER ASSEMBLY
4. ROD (Reference dimension 3.39 inches \pm by 0.02 inches)
5. BELL CRANK
6. ROD
7. LEVER

(b) Modify the airframe condition control linkage by adjusting Rod 1 and Levers 2 and 7 as specified in Figure 1 of this AD in accordance with Chapter 6, Section 9.2, of the applicable Mitsubishi MU-2 maintenance manual.

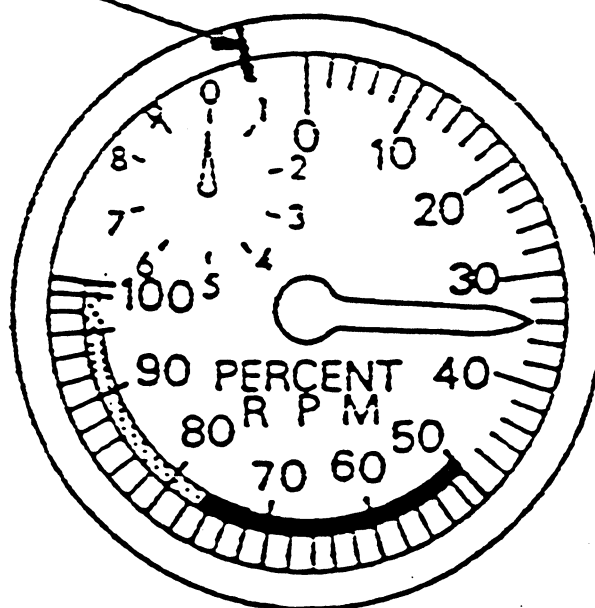
slip stripe

(2) Using white lacquer (MIL-L-7178, color number 511 or equivalent), apply a 1/16-inch wide by 1/4-inch long slip stripe over the tachometer glass and indicator case at the 11:30 o'clock position as specified in Figure 2 of this AD.
