**TITEL:** Inspektion och modifiering av huvudrotorväxel.

**GÄLLER:** Modell R 22 med huvudrotorväxel med P/N A006-1 Rev A tom Z, tillverkade eller översedda efter 15 juni 1992.

**LFS: 1995:39**

## 95-06-03 ROBINSON HELICOPTER COMPANY: Amendment 39-9276. Docket No. 94-SW-27-AD.

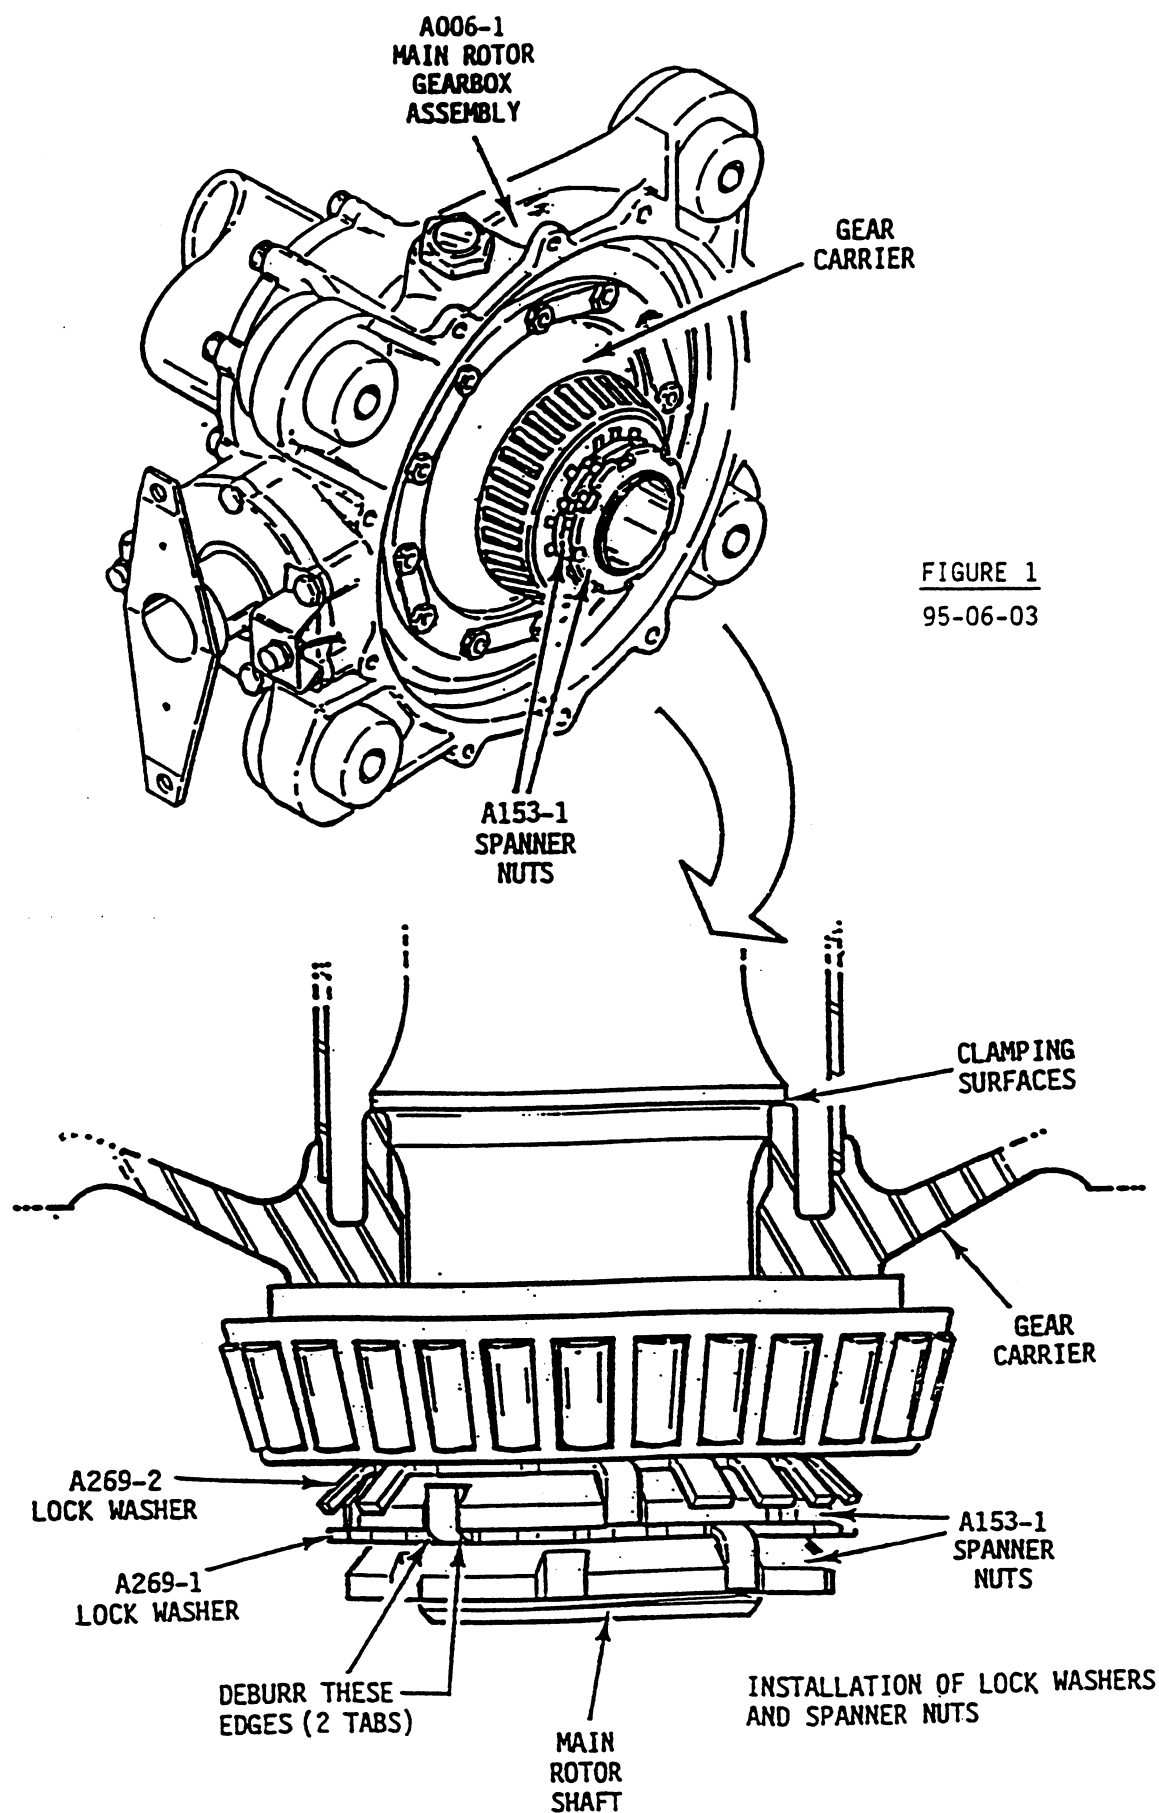
(viii) Before installing the lock washer, P/N A269-1, note that the edges are sharp on one side and rounded on the other. De-burr the sharp edges on two opposite tabs (see figure 1). This will reduce the chance of cracking when these tabs are bent up. Install the lock washer with the rounded edges toward the installed nut.

(ix) Apply anti-seize, P/N A257-9, to the chamfered-side face and threads of the lower nut. Align the two de-burred tabs with the upper nut and install the lower nut with the chamfered side against the lock washer. Hand-tighten the nut to hold the washer in place. Bend the two de-burred tabs up to lock with the upper nut. Torque the lower nut to between 90 and 120 ft.-lb., as required to align the two additional tabs. Do not untorque the nut to align the lock washer tabs with the nut. For the two tabs that are aligned with the recessed areas, bend down the tabs into the recessed areas of the nut to lock the lower nut.

(x) Verify that all six bent tabs properly engage the nuts (four tabs to the upper nut and two to the lower nut), and inspect the edges of the bent tabs for cracks. Replace any cracked lock washers. Remove excess anti-seize compound.
