TITEL: Kontroll av stjärtrotorväxel för avsaknad av låskil.

GÄLLER: Modell R22 med installerad växel tillverkad eller översedd av Robinson Helicopter Company före 8 juni 1992, undantaget växlar med S/N angivna i bifogad kopia av FAA AD 95-23-05.

LFS: 1995:69

95-23-05 ROBINSON HELICOPTER COMPANY: Amendment 39-9425. Docket No. 95-SW-06-AD. Supersedes AD 94-17-07, Amendment 39-9059.

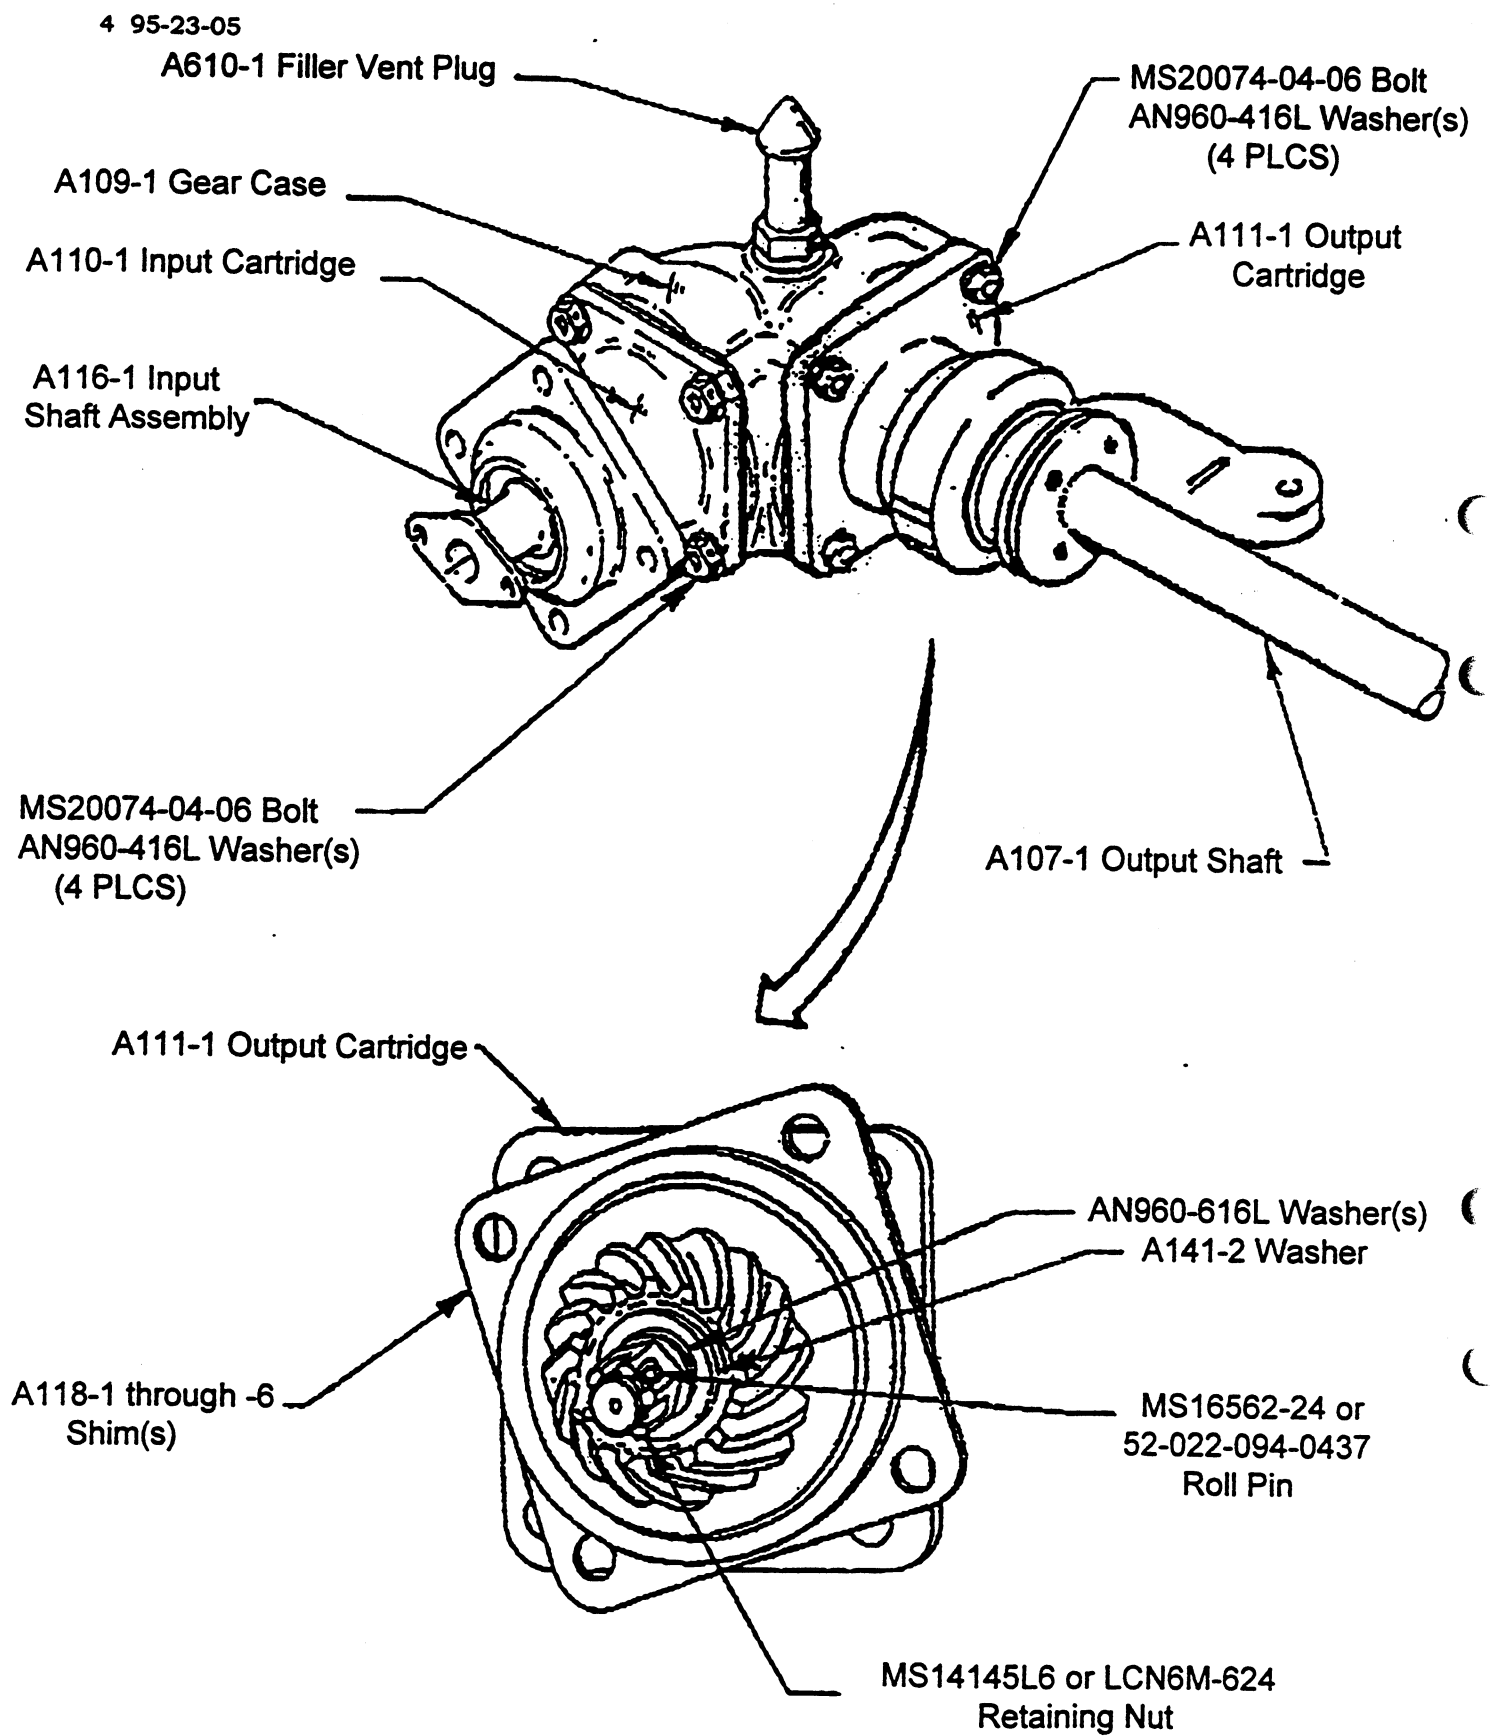
Figure 1

Note: The safety wire has been removed for clarity

(4) Remove and disassemble the output cartridge, P/N A111-1, from the T/R gearbox case, P/N A109-1 (see figure 1) as follows:

(ii) Cut and remove the safety wire around the four MS20074-04-06 bolts securing the output cartridge to the gear case. Remove and retain each of the four bolts and their associated AN960-416L washer(s), noting the washer stacks for reassembly. Separate the output cartridge from the gear case (see figure 1).

(ii) Cut and remove the safety wire around the four MS20074-04-06 bolts securing the input cartridge to the gear case. Remove each of the four bolts and their associated AN960-416L washer(s), noting the washer stacks for reassembly. Separate the input cartridge from the gear case (see figure 1).

(iii) Secure the input cartridge to a block of wood through the two bolt holes in the input shaft assembly, P/N A116-1 (see figure 1). Place the block of wood in a vise. Remove and discard the safety wire, roll pin, and retaining nut. Remove the AN960-616L washer(s), and washer, P/N A141-1, noting the washer(s) location for reassembly. Do not damage the input shaft or shim(s), P/N A118-1 through -6, located next to the flange of the input cartridge.

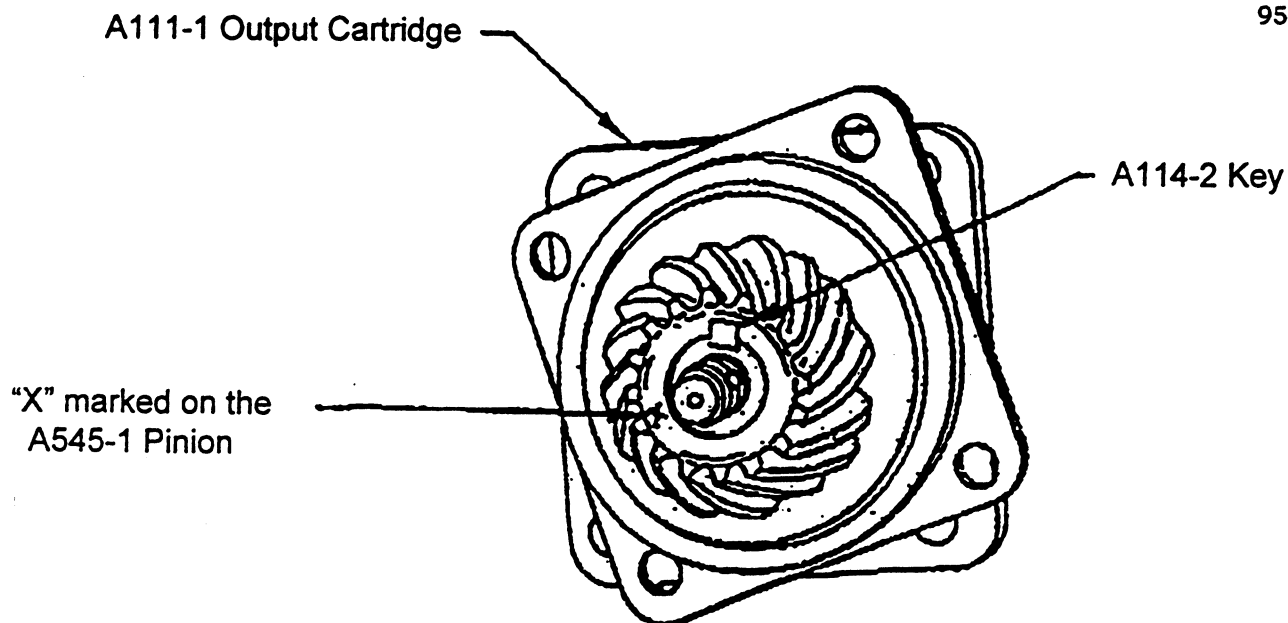
Figure 2

(iv) Visually inspect for the presence of the output shaft key, P/N A114-2, between the pinion gear, P/N A545-1, and the output shaft (see figure 2).

(iv) Visually inspect for the presence of the input shaft key, P/N A114-1, between the gear, P/N A545-2, and the input shaft (see Note on figure 2).

Note: The A114-1 Key for the A110-1 Input Cartridge is located similar to the A111-1 Output Cartridge depicted above

(v) If the output shaft key is missing, replace the T/R gearbox with an airworthy gearbox that has been determined to have the output key installed. Report any T/R gearbox that has a missing key within 10 days after the inspection to the Manager, Los Angeles Manufacturing Inspection Office, FAA, Northwest Mountain Region, 3960 Paramount Blvd., Lakewood, California 90712, telephone (310) 627-5290, fax (310) 627-5293. Reporting requirements have been approved by the Office of Management and Budget and assigned OMB control number 2120-0056.

(v) If the input shaft key is missing, replace the T/R gearbox with an airworthy gearbox that has been determined to have the input key installed. Report any T/R gearbox that has a missing key within 10 days after the inspection to the Manager, Los Angeles Manufacturing Inspection District Office, FAA, Northwest Mountain Region, 3960 Paramount Blvd., Lakewood, California 90712, telephone (310) 627-5290, fax (310) 627-5293. Reporting requirements have been approved by the Office of Management and Budget, and assigned OMB control number 2120-0056.
