**TITEL:** Kontroll av motorns urluftningssystem

**GÄLLER:** Alla Z 242 L

Number: CAA AD - 2 - 012/ 96

**AIRCRAFT - OIL SYSTEM - SERVICE AT LOW TEMPERATURE**

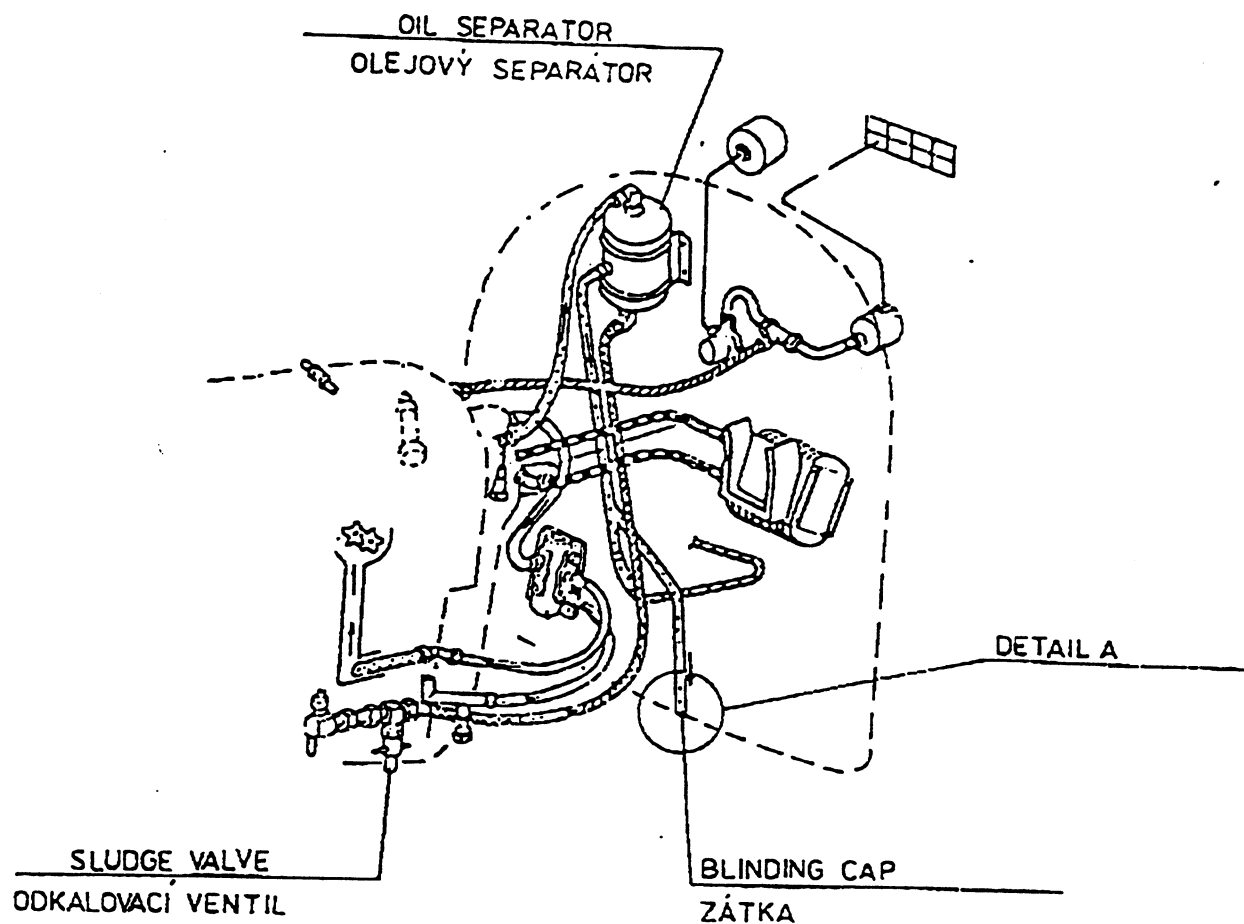
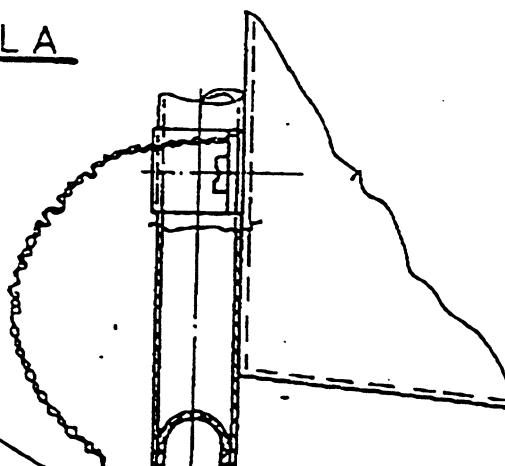
DETAIL A

**3. Reason for Issuance:** at the low ambient air temperature (below +5° C on ground) can occur freeze-up of main engine vent line and of the rubber cap in the secondary engine vent line. This can lead to forcing-out of the front crankcase seal ring and oil leakage from the engine in several events.

ZÁTKU VYJMOUT  
TAKE OUT THE

a/ during cold weather operation and always when ambient ground air temperature drops below +5° C accomplish the following. Remove the rubber cap from the secondary engine vent line and to check the line for free passage. See figure. Install blind flanges into engine cooling air inlet openings. The cold weather operation is defined, preparation of the aircraft for this operation as well as the aircraft maintenance in the course of it are specified in the Maintenance Manual - Vol. I. Chapter 3. There is also described installation of blind flanges into the engine cooling air inlets.

At the low ambient air temperature (below +5° C on ground) remove rubber cup from the secondary engine vent line, check this line for free passage (remove ice plug if any) and install screens into the engine cooling air inlets.
