TITEL: Kontroll av oljefilteradaptorns montering

ÅTGÄRD: Enligt bifogad kopia av FAA AD 96-12-22

96-12-22 CESSNA AIRCRAFT COMPANY: Amendment 39-9665; Docket No. 93-CE-54-AD.

Figure 1 Oil Filter Adapter Installation
AD 96-12-22

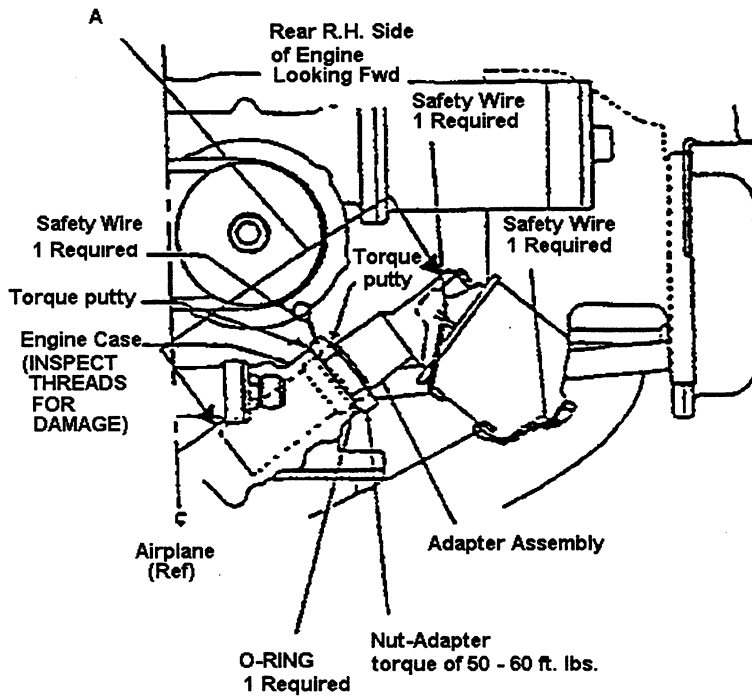
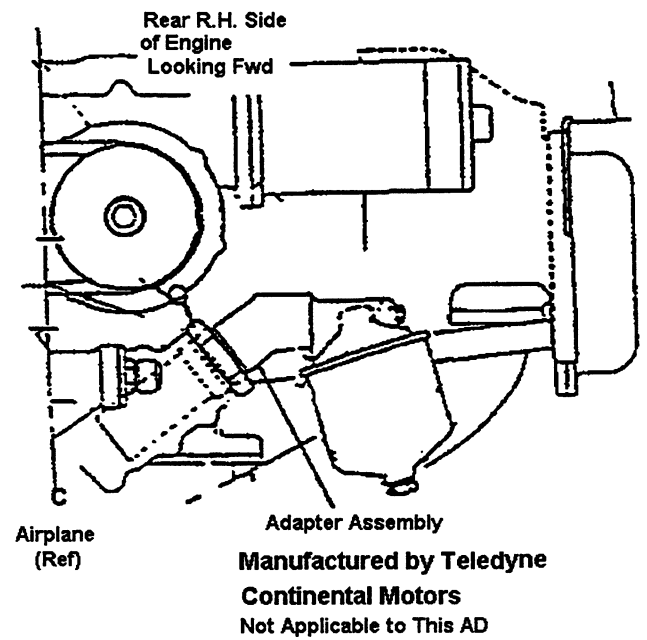
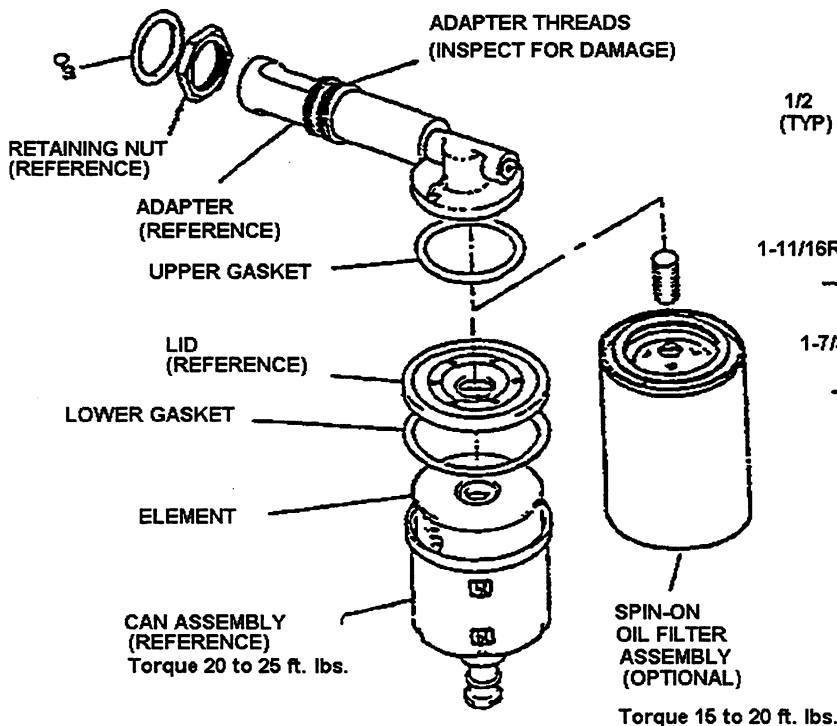
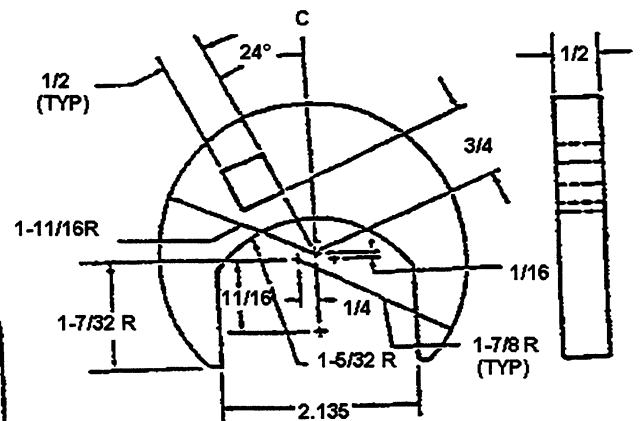
NOTE 2: This AD does not apply to engine oil filter adapter assemblies manufactured by Teledyne Continental Motors (See Figure 1 of this AD).

(a) For airplanes with engine oil filter adapter assemblies that do not have torque putty between the engine filter adapter assembly, nut, and oil pump housing, accomplish the following:

(b) For airplanes with torque putty between the engine filter adapter assembly, nut, and oil pump housing, inspect the torque putty for misalignment, evidence of oil leakage, or cracks.

- (1) Inspect the adapter locking nut installation for evidence of oil leakage.
- (2) Check the torque of the adapter nut installation and ensure that the torque value is within the limits of 50 through 60 foot pounds.
- (3) If evidence of oil leakage is found or the torque is not within the 50 through 60-foot pound limit, prior to further flight, remove the adapter and filter assembly, and:
 - (i) Inspect the threads of the adapter assembly and engine for signs of damaged or cracked threads; and
 - (ii) Replace any adapter assembly and engine oil pump housing (if necessary) that have evidence of thread damage or cracks.
- (4) Apply torque putty between the engine filter adapter assembly, nut, and oil pump housing as specified in Figure 1 of this AD.
- (5) Reassemble the engine oil filter assembly.

- (1) If any misalignment, evidence of oil leakage, or torque putty cracks are found, prior to further flight, accomplish the requirements specified in paragraph (a) of this AD, including all subparagraphs.
- (2) If no misalignment, evidence of oil leakage, or torque putty cracks are found, reinspect at intervals not to exceed 100 hours TIS until the engine oil filter is removed.
