TITEL: Modifiering av STOL-sats enligt STC SA1371SW

GÄLLER: Modeller 150 och 152 enligt bifogad kopia av FAA AD 96-12-23 med modifiering enligt STC SA1371SW

96-12-23 THE CESSNA AIRCRAFT COMPANY: Amendment 39-9666; Docket No. 95-CE-14-AD.

FIGURE 1
MID-AMERICA DWG NO. 1001
(STC SA1371\$W)

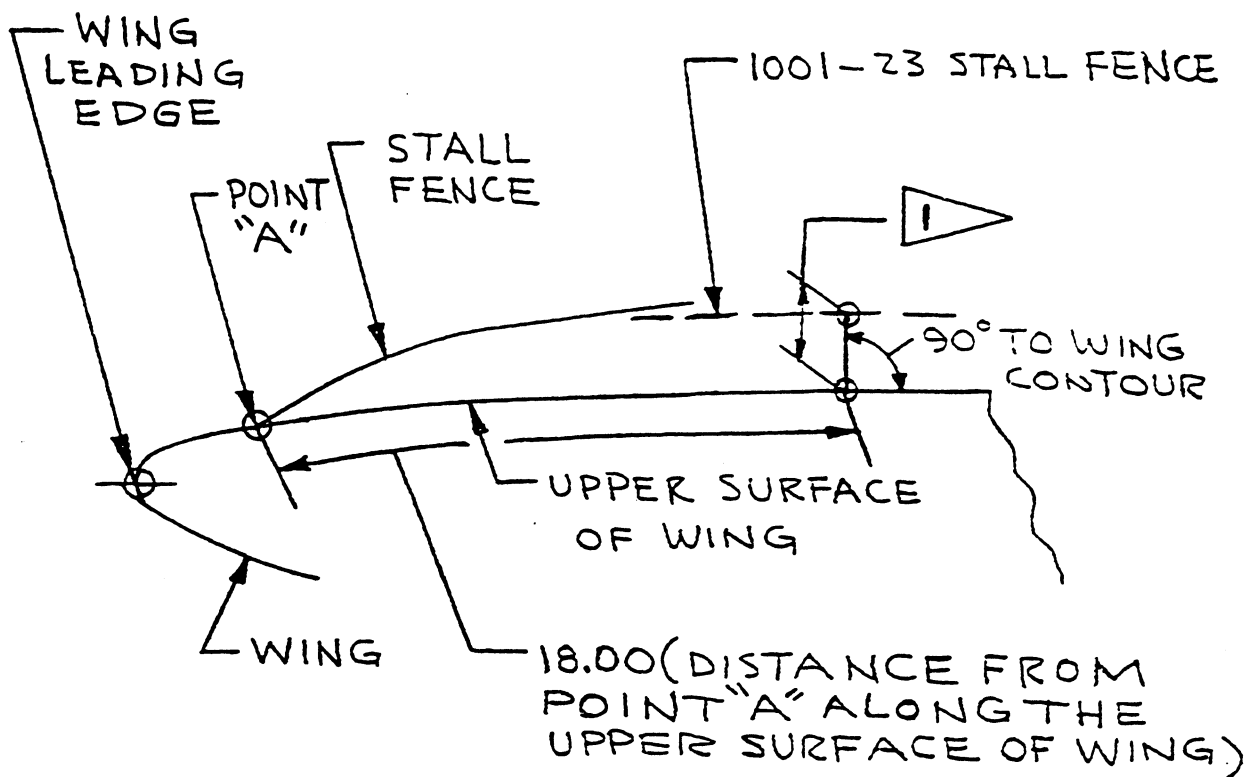
To prevent the airplane operator from entering a stall condition because of improper wing stall fence height, which, if not detected and corrected, could result in loss of control of the airplane, accomplish the following:

(a) Measure the height of the wing stall fence at its trailing edge to ensure that the height does not exceed 1.28 inches. (See Figure 1 of this AD).

1 IF STALL FENCE IS $1.16 \pm .12$ HIGH THAT IS CORRECT HEIGHT FOR CESSNA 150/152. IF GREATER THAN 1.28 HIGH REMOVE STALL FENCES AND INSTALL THE CORRECT ONE.

(b) If the wing stall fence height exceeds 1.28 inches, prior to further flight, install a smaller fence in accordance with instructions obtained from the Wichita Aircraft Certification Office (ACO), FAA, 1801 Airport Road, Mid-Continent Airport, Wichita, Kansas 67209.
