**TITEL:** Sprickkontroll av landställens "Side Brace Stud"

**LFS 1998:87**

# REVISED AIRWORTHINESS DIRECTIVE

## 97-01-01 R1 THE NEW PIPER AIRCRAFT, INC.: Amendment 39-10864; Docket No. 96-CE-09-AD.

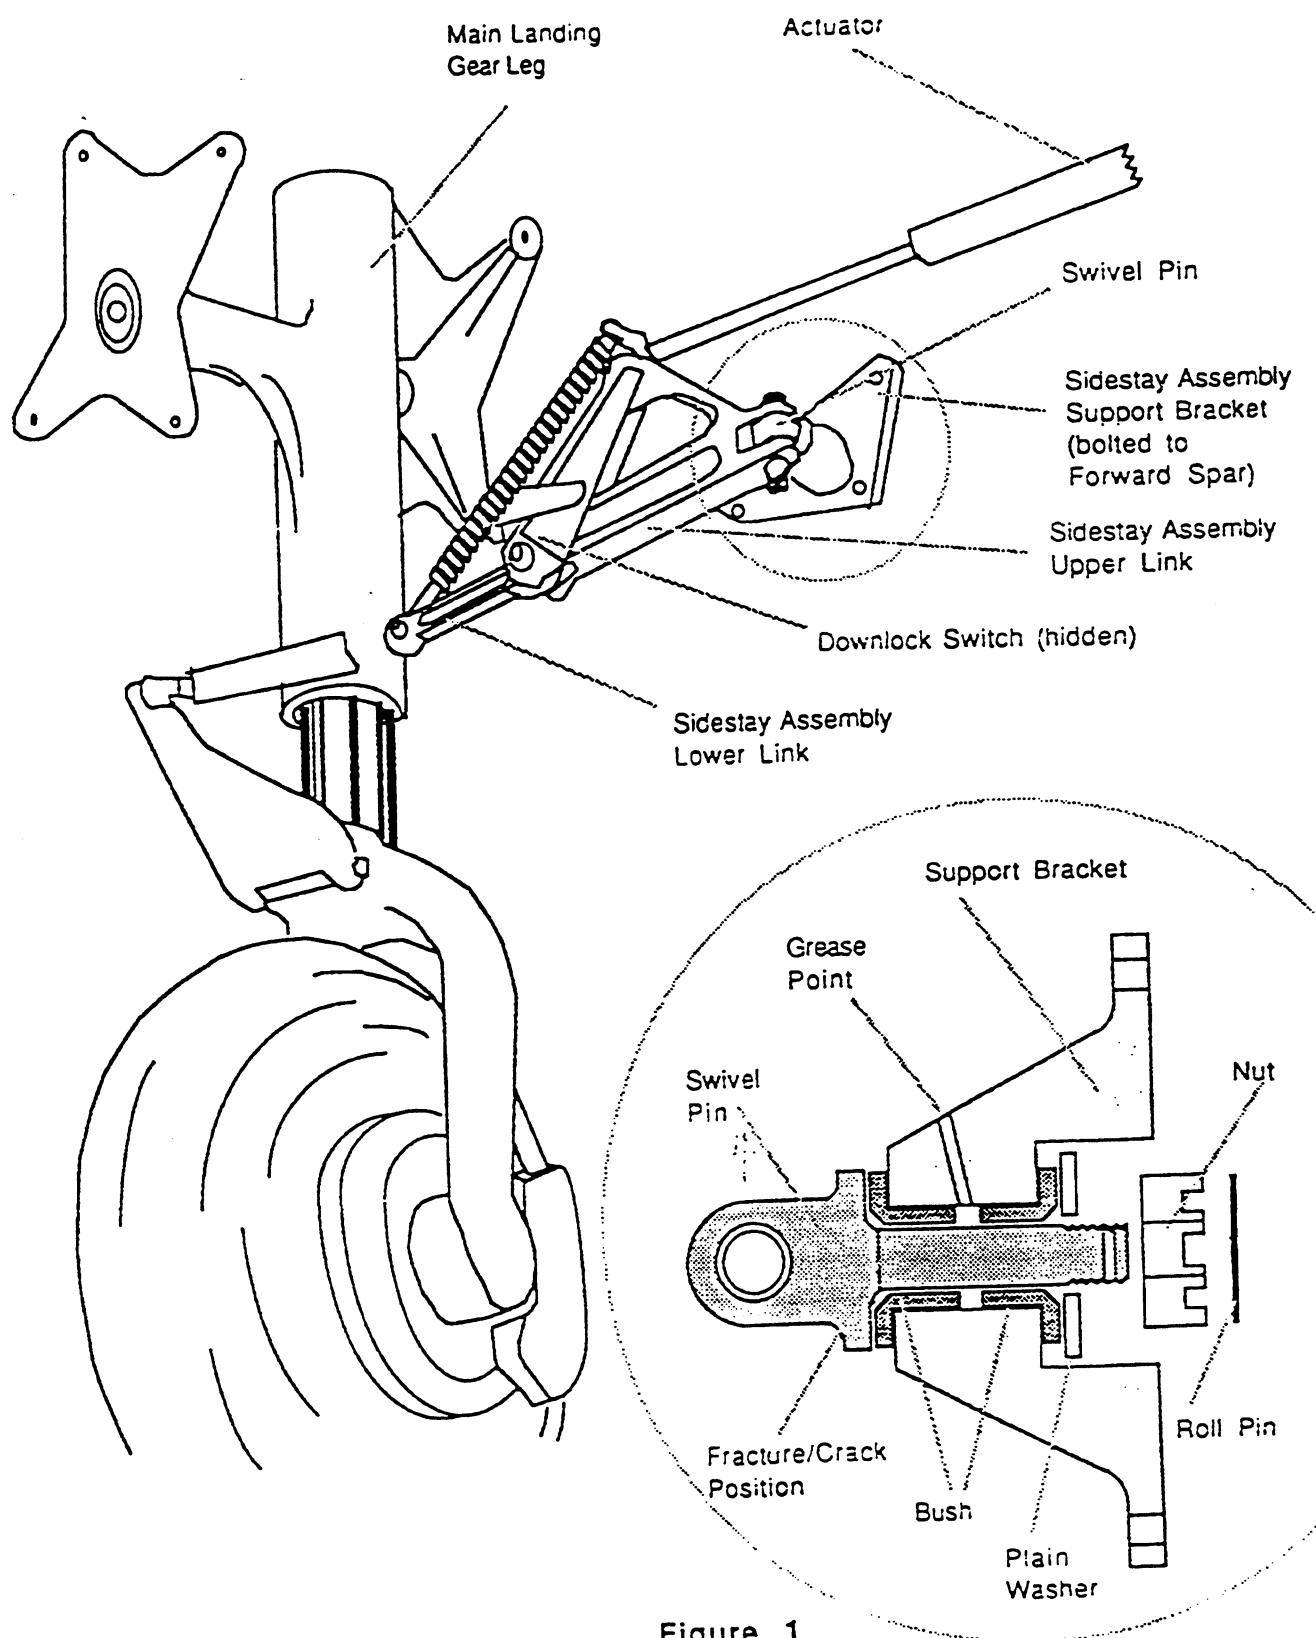
**Figure 1**

(a) Remove both the left and right main gear sidebrace studs from the airplane in accordance with the instructions contained in the Landing Gear section of the maintenance manual, and inspect each main gear sidebrace stud for cracks, using Type I (fluorescent) liquid penetrant or magnetic particle inspection methods. Figure 1 of this AD depicts the area of the sidebrace stud shank where the sidebrace stud is to be inspected.
