**TITEL:** Kontroll av bränsle-, olje- eller hydraulslangar

**GÄLLER:** Cessna 100, 200, 300 och 400 serierna med modeller och S/N angivna i bifogad kopia av FAA AD 97-01-13

**LFS 1997:11**

**97-01-13 CESSNA AIRCRAFT COMPANY:** Amendment 39-9884; Docket No. 96-CE-46-AD.

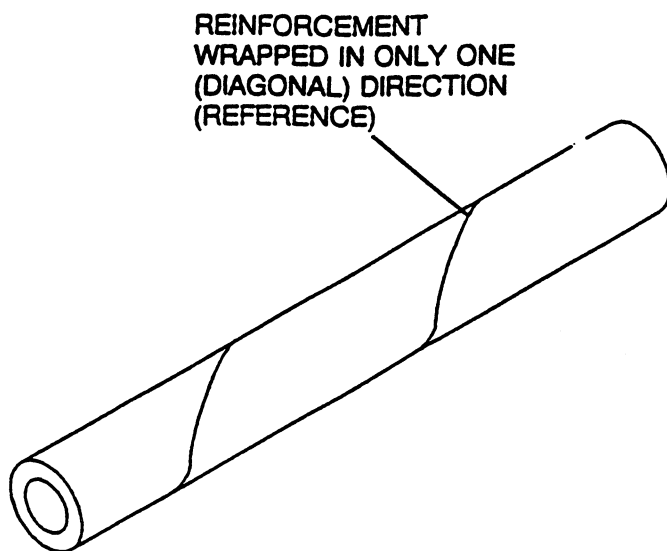
AD 97-01-13  
Figure 1

NOTE 2: Figure 1 of this AD is included to show the diagonal or spiral external reinforcement wrap on the hose that is referenced in the check required by paragraph (b) of this AD.

OLD STYLE S51-10 HOSE  
WITH REINFORCEMENT  
WRAPPED IN ONLY ONE  
(DIAGONAL) DIRECTION THE  
LENGTH OF THE HOSE  
(REMOVE AND REPLACE WITH  
REPLACEMENT STYLE HOSE)

(c) Prior to further flight after the check required by paragraph (b) of this AD, replace any Cessna P/N S51-10 that has a diagonal or spiral pattern external reinforcement wrap with a Cessna P/N S51-10 hose that has a criss-cross pattern external wrap. Accomplish this replacement in accordance with the ACCOMPLISHMENT INSTRUCTIONS of the applicable service bulletin in paragraph (b) of this AD.

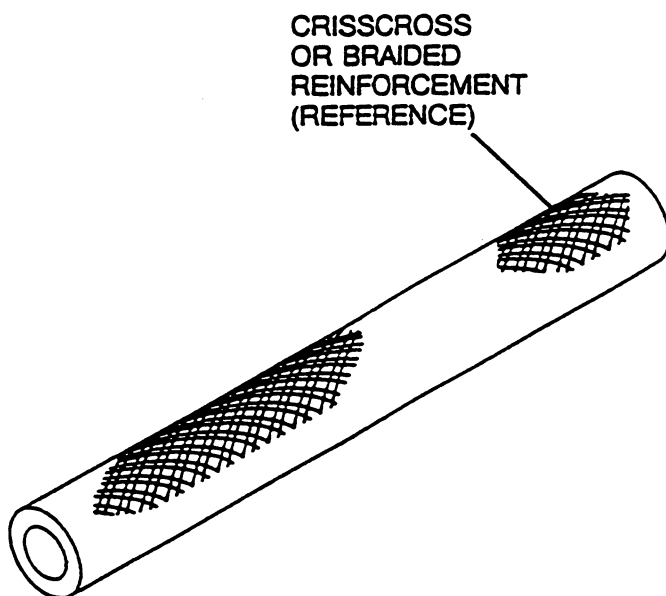
REPLACEMENT STYLE S51-10  
HOSE WITH A CRISS-CROSS  
OR BRAIDED REINFORCEMENT  
PATTERN
