AIRWORTHINESS DIRECTIVE No: 1-032

AIRCRAFT TYPE: SAAB MFI 9, 9B, 9C

SUBJECT: Inspection of fuselage for corrosion damages

SERVICE BULLETIN NO: MFI 9/9-1989

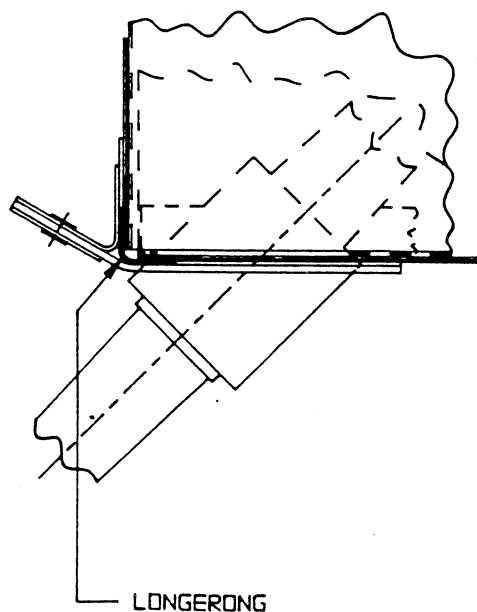
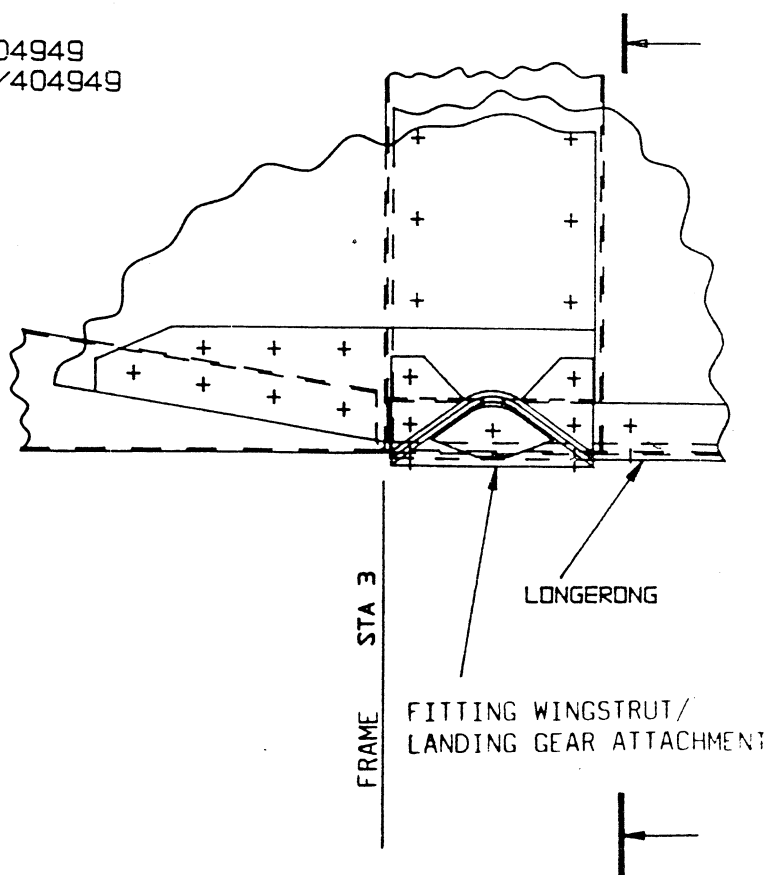
Aircrafts with corrosion damages on the lower longeron around the fitting for wingstrut-/landing gear attachment, and cracks in the above mentioned fittings have been discovered.

Check visually if there is any corrosion.
The check shall be performed at the next 50 or 100 h inspection, but not later than 1989-06-30.
