**TITEL:** Ändring av fastsättning för säkerhetsbälte

**GÄLLER:** PZL-104 "Wilga 35" för flygplan som används för fallskärmshoppning

## SERVICE BULLETIN NO. 1197173 MANDATORY

**Concerns:** Changes in the attachment of the forward starboard breast safety belt in PZL-104-Wilga 35 airplanes, accommodated for parachute jumping.

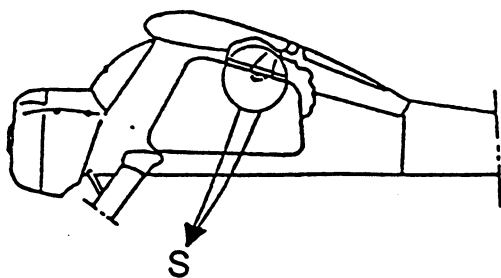
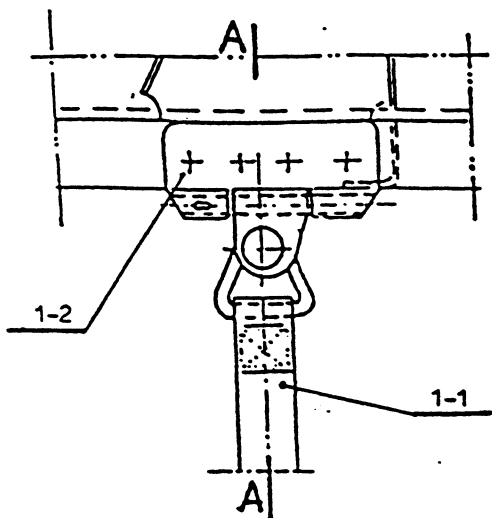
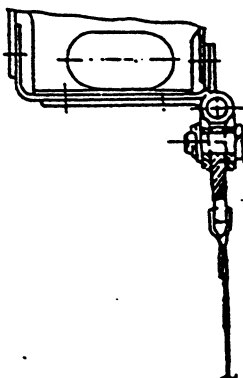
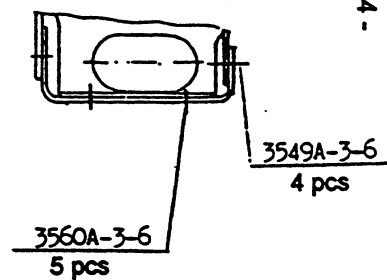
After removing  
ferrule 1-2

1. Disjoin the starboard breast safety belt No. 1-1 Fig. 1 [restore the bolt].
2. Unscrew at the R.H. side the shield No. 2-3 and the upholstery mouldings Nos. 2-1 and 2-2 of the door. Fig. 2 [the screws to be restored].
3. Deflect the upholstery.
4. Unrivet the ferrule No. 1-2 Fig. 1.
5. The holes remaining, to be plugged with rivets 3560A-3-6 – 6 each of, and 3549A – 4 each of, as in section A1 - A1 Fig. 1.
6. Drill holes according to measurements given in Fig. 3:
  - Ø 3,3 for rivets joining the upper flange of the bracket with the stringer
  - Ø 3,1 for rivets joining the lower flange of the bracket with the edge of the door.
  - Ø 2,7 for rivets joining the riveted nuts with the lower flange and the edge of the door.
7. Have riveted the bracket No. 3-1 according to Fig. 3, as per
8. Have bolted the ferrule No. 3-2 Fig. 3.
9. Have the upholstery cut as per Fig. 4.

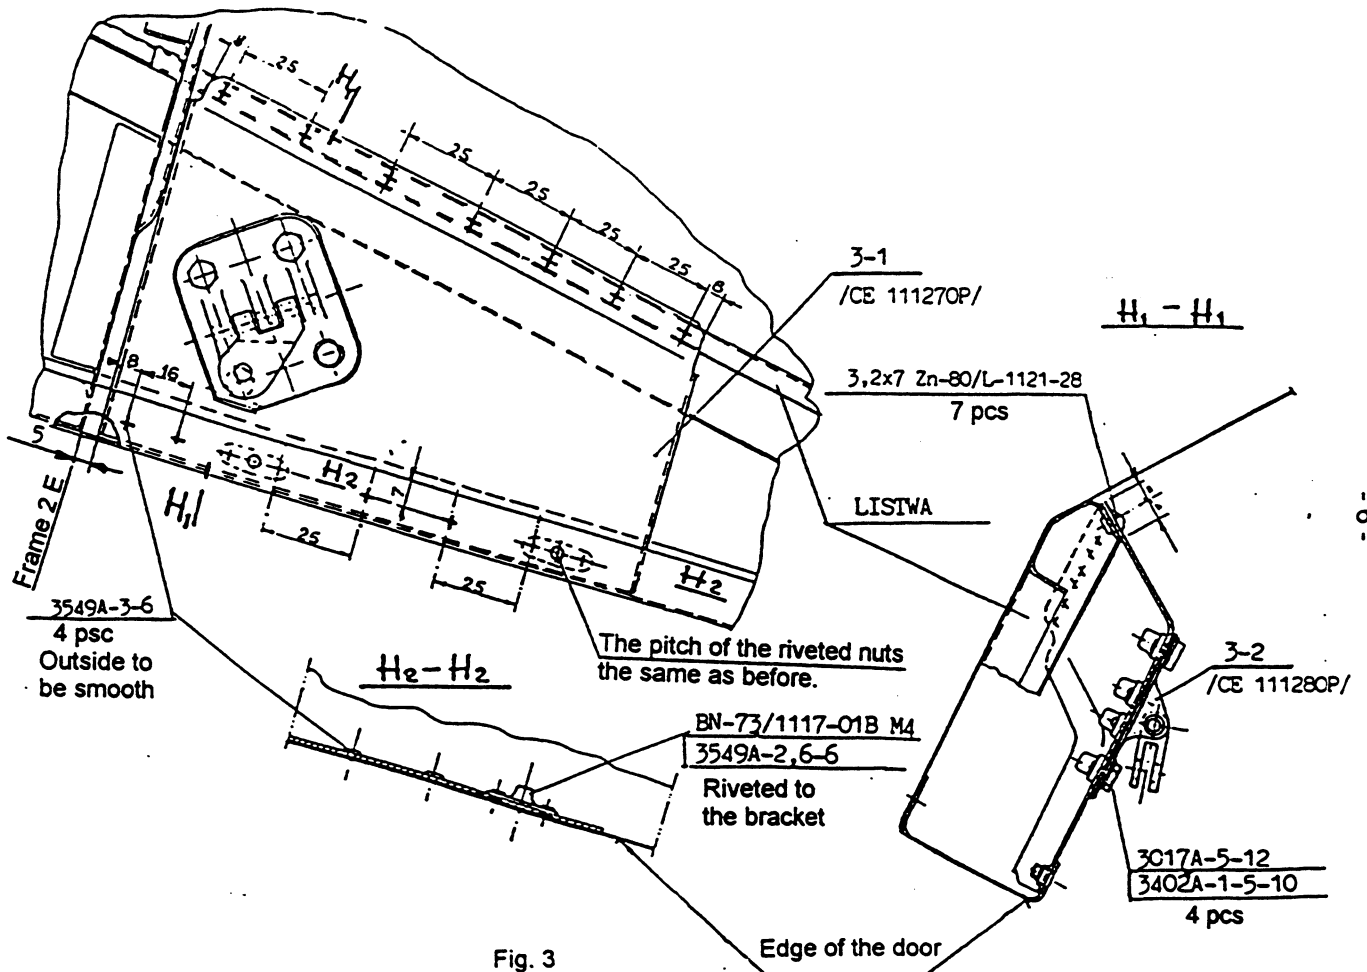
Fig. 3

This bulletin is to inform, that in PZL-104 Wilga 35 airplanes utilized in parachute jumping operations, the upper ferrule of the starboard forward breast safety belt must be replaced by a new one and fixed and localized as shown in Fig. 3.

- 10. Relocate the upholstery, fix with screws the upholstery moulding No. 2-2 and a new moulding No. 4-1 instead of No. 2-1, and the shield No. 2-3.
- 11. Connect the breast safety belt No. 1-1 to ferrule No. 3-2.
